# Great Malvern's Creation Window The Conservation and Protection of a Medieval Treasure

Professor Sarah Brown FSA FRHistS

Director, The York Glaziers Trust

# Findings of the 2015 survey

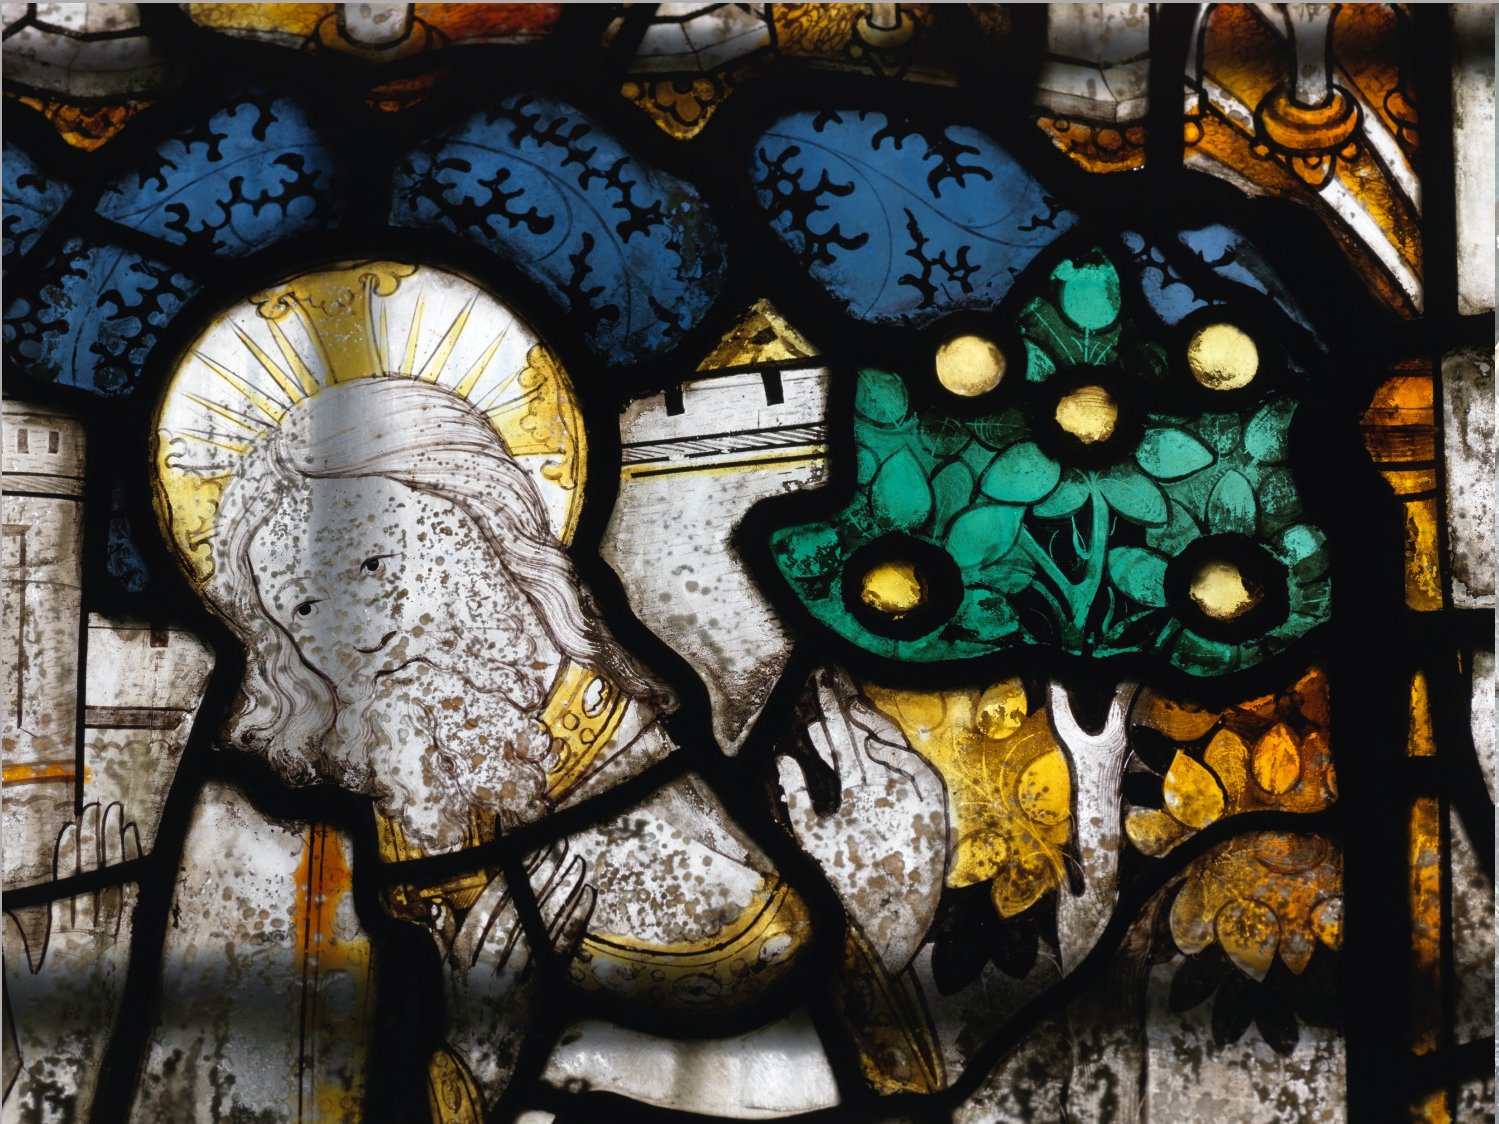
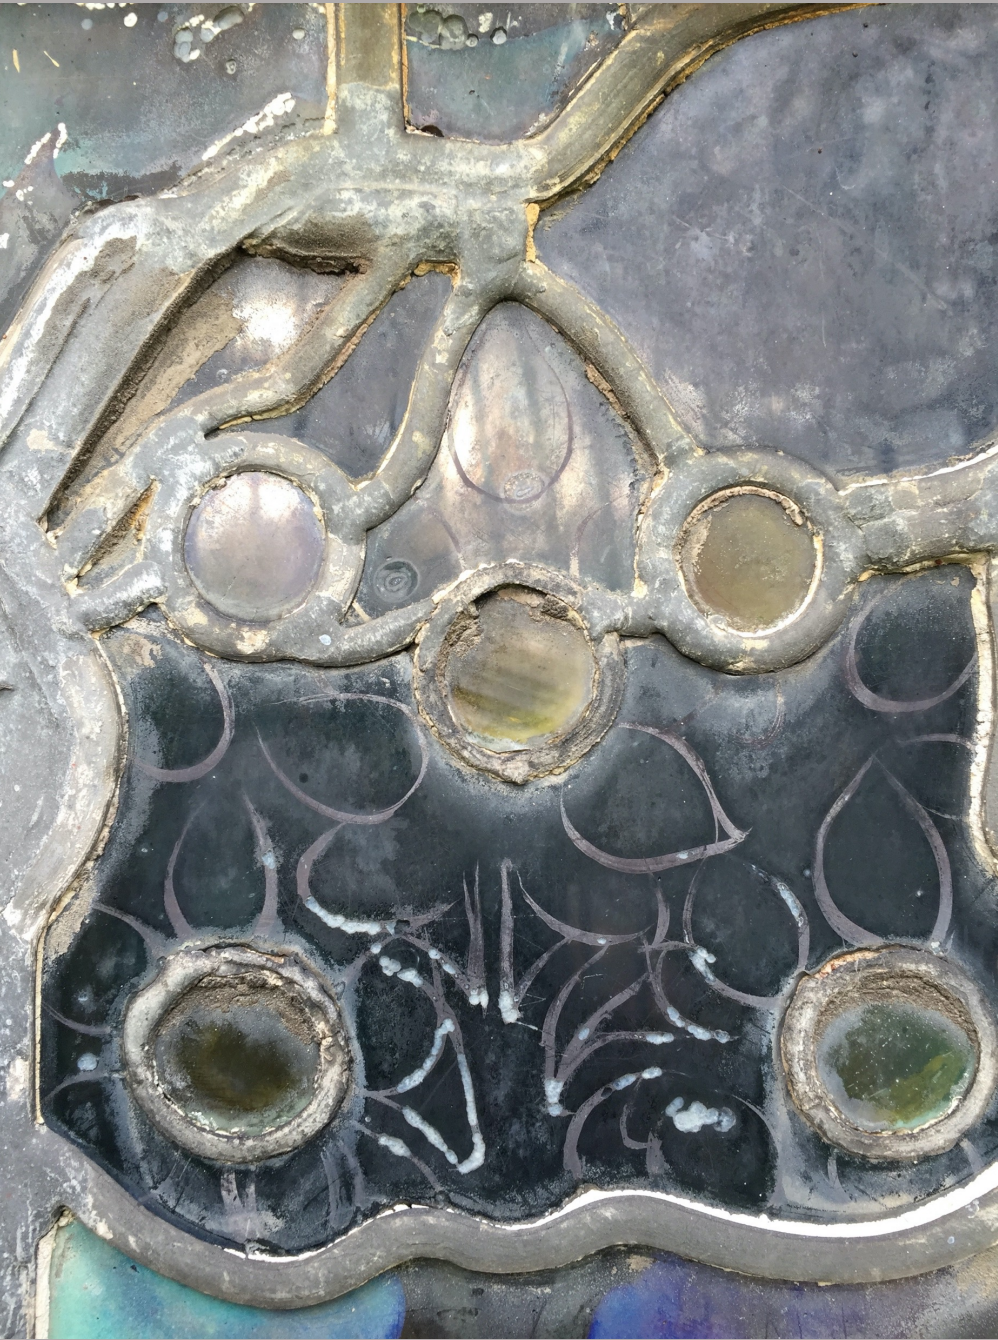
Drilled 'jewels' in surviving medieval leads

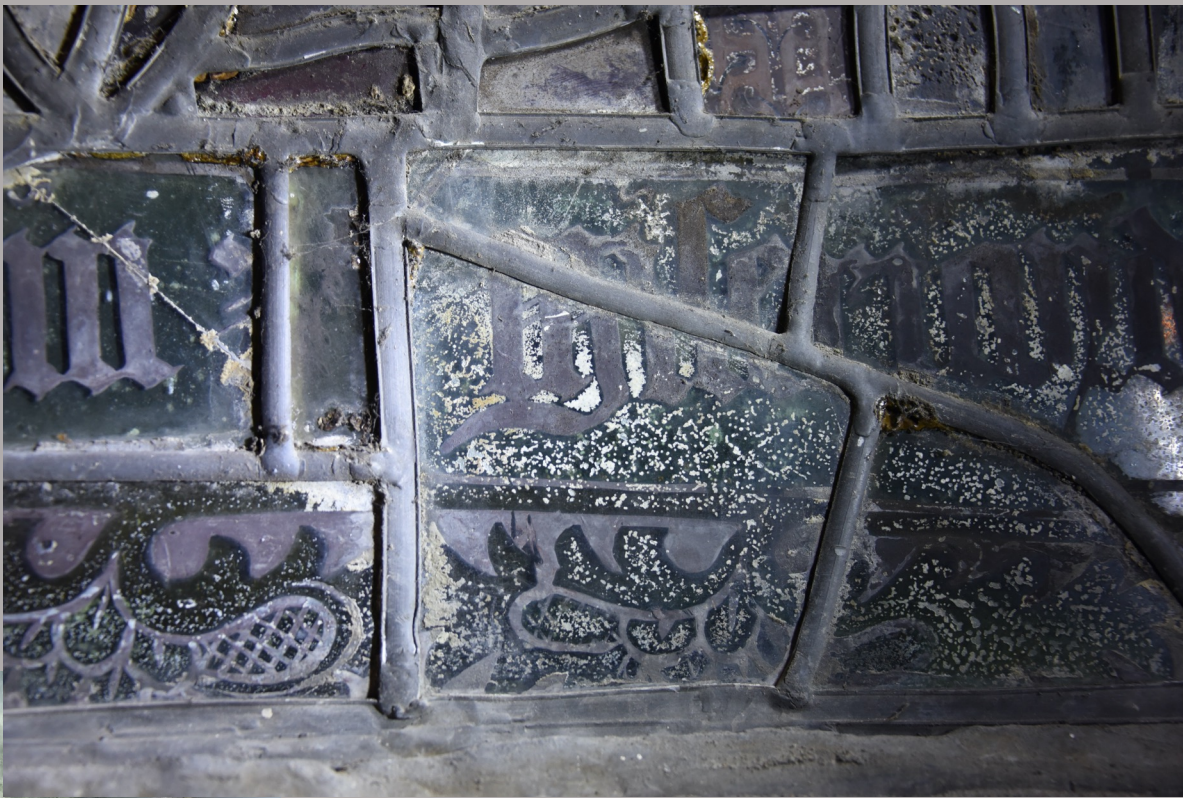
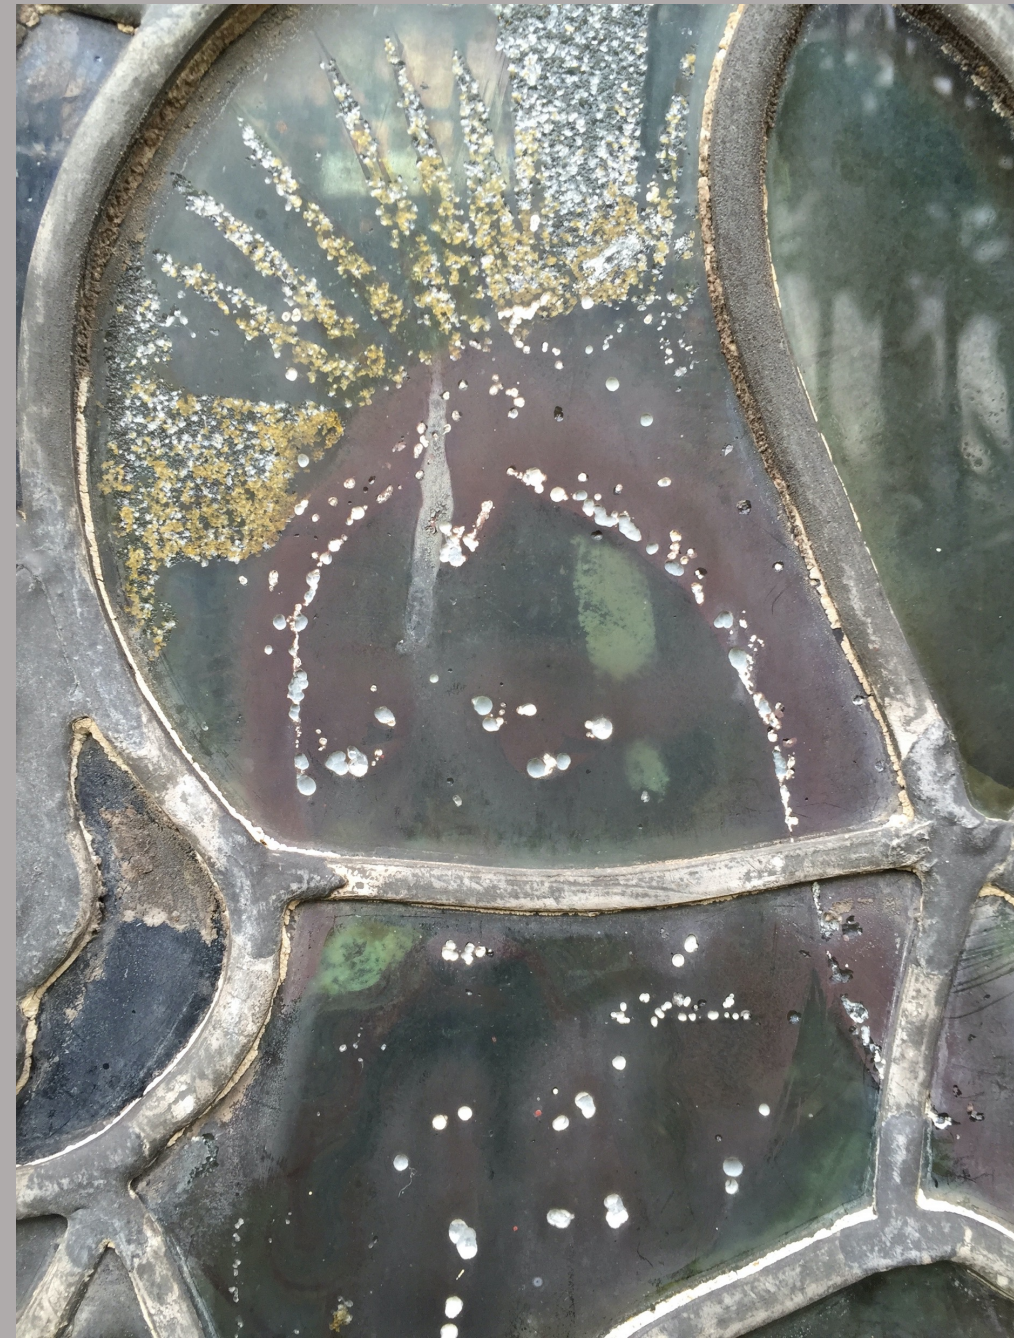
Serious glass corrosion on both  
surfaces

Lichen growth on exterior

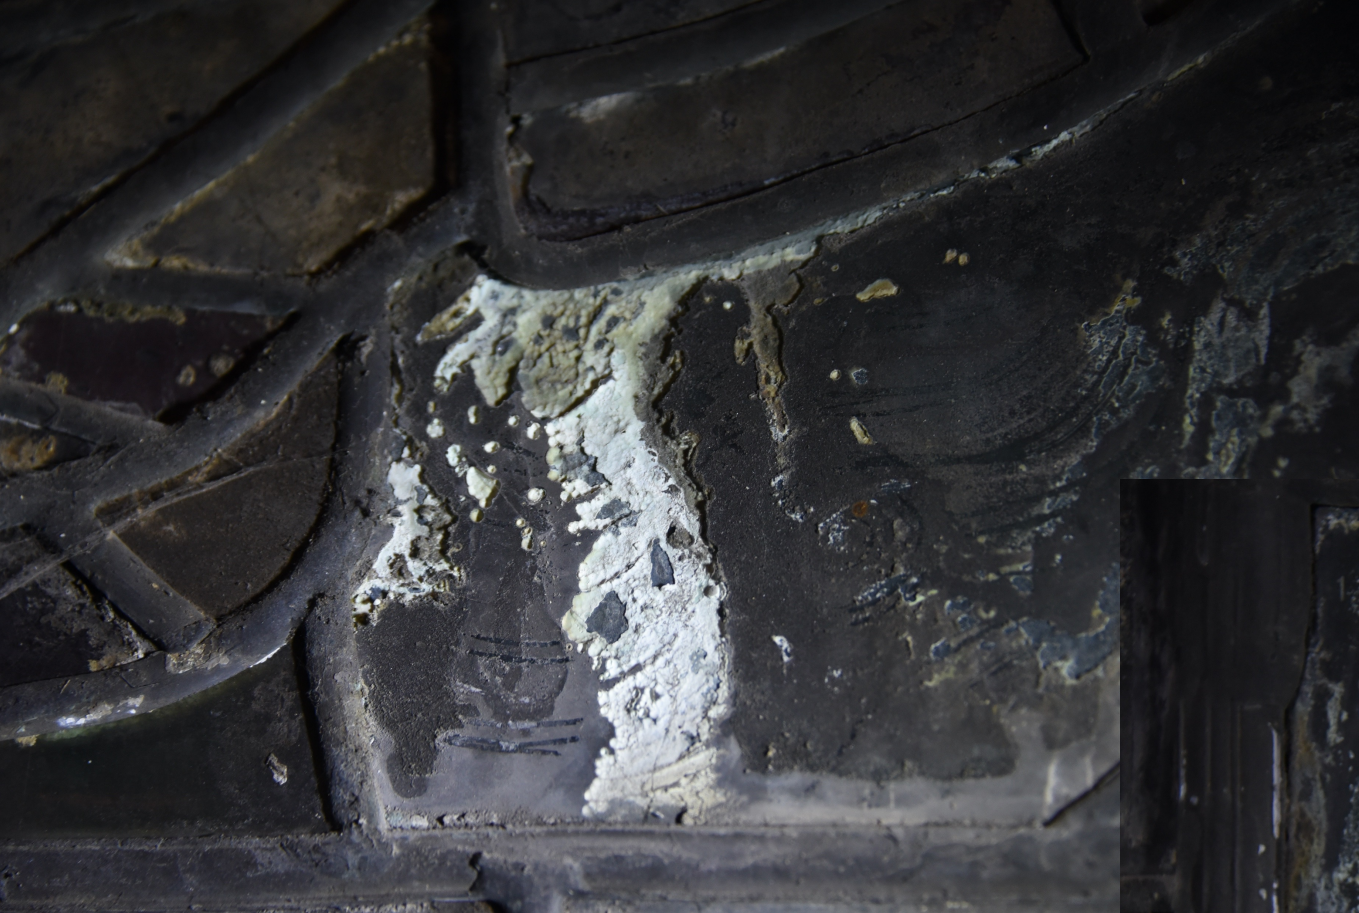
Lost and fragile paint surfaces

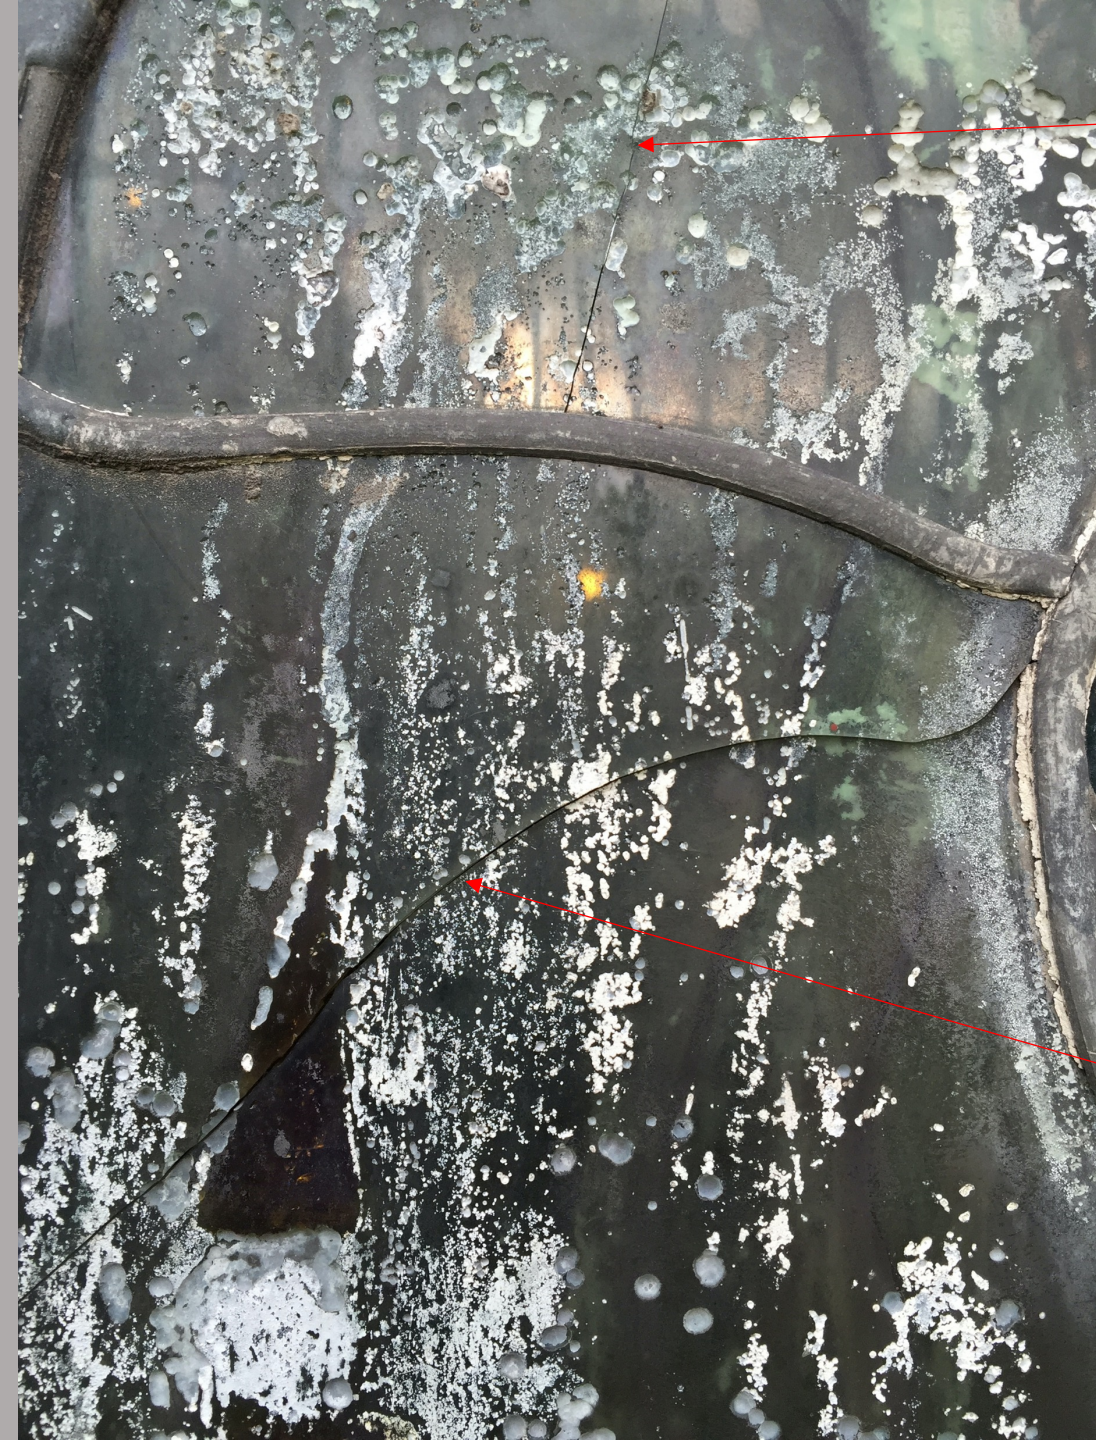
Cracked glass and  
failure of past  
repairs

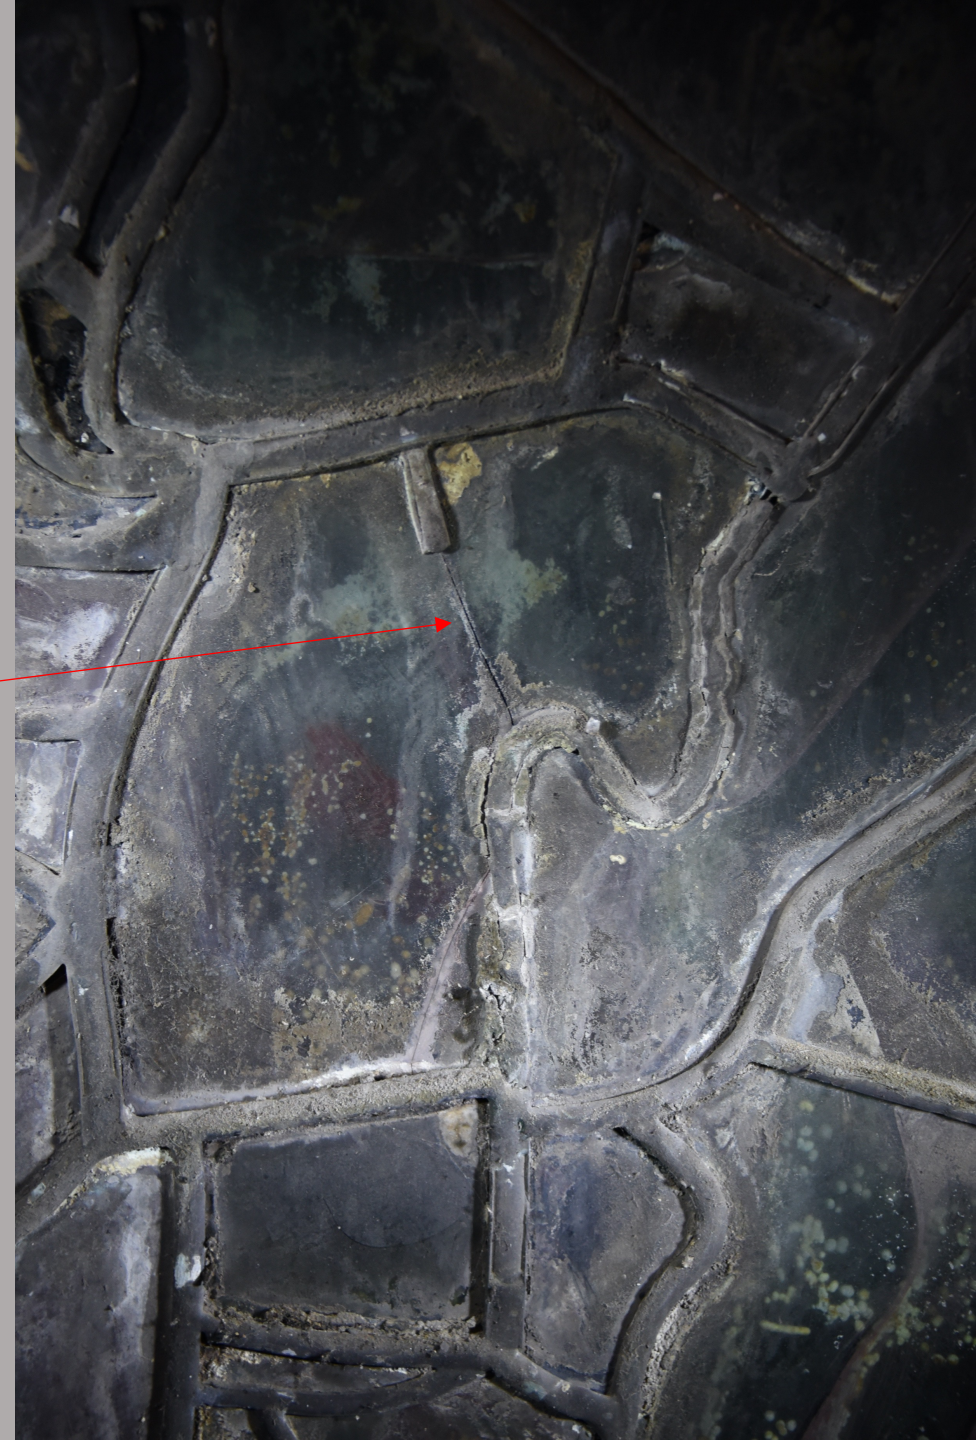
Lost and oozing waterproofing

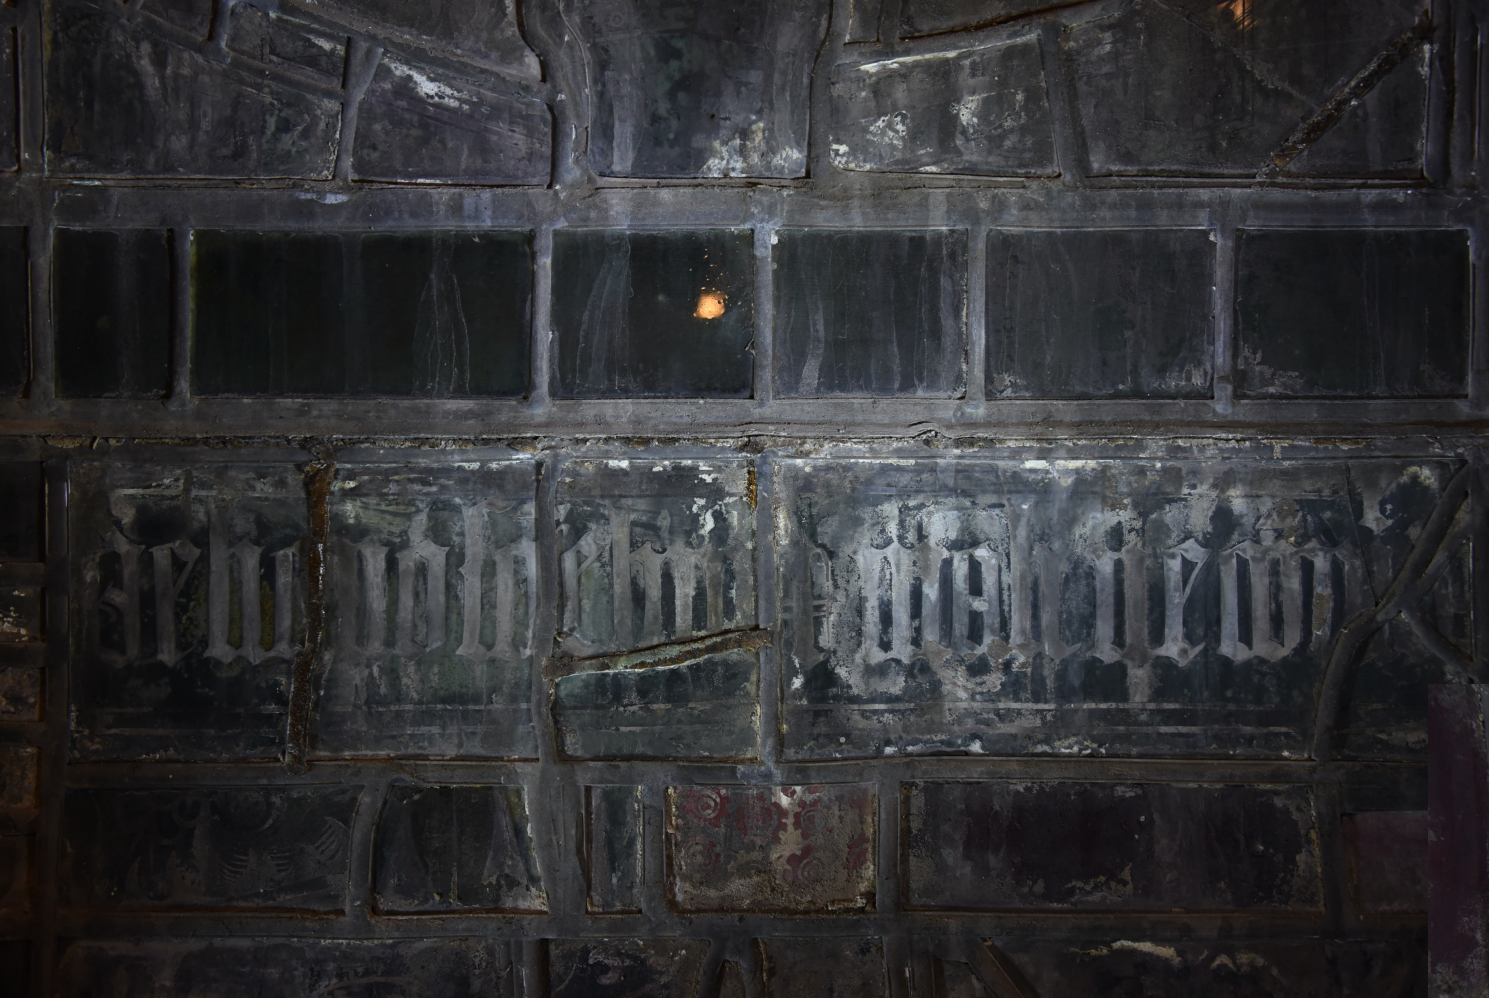
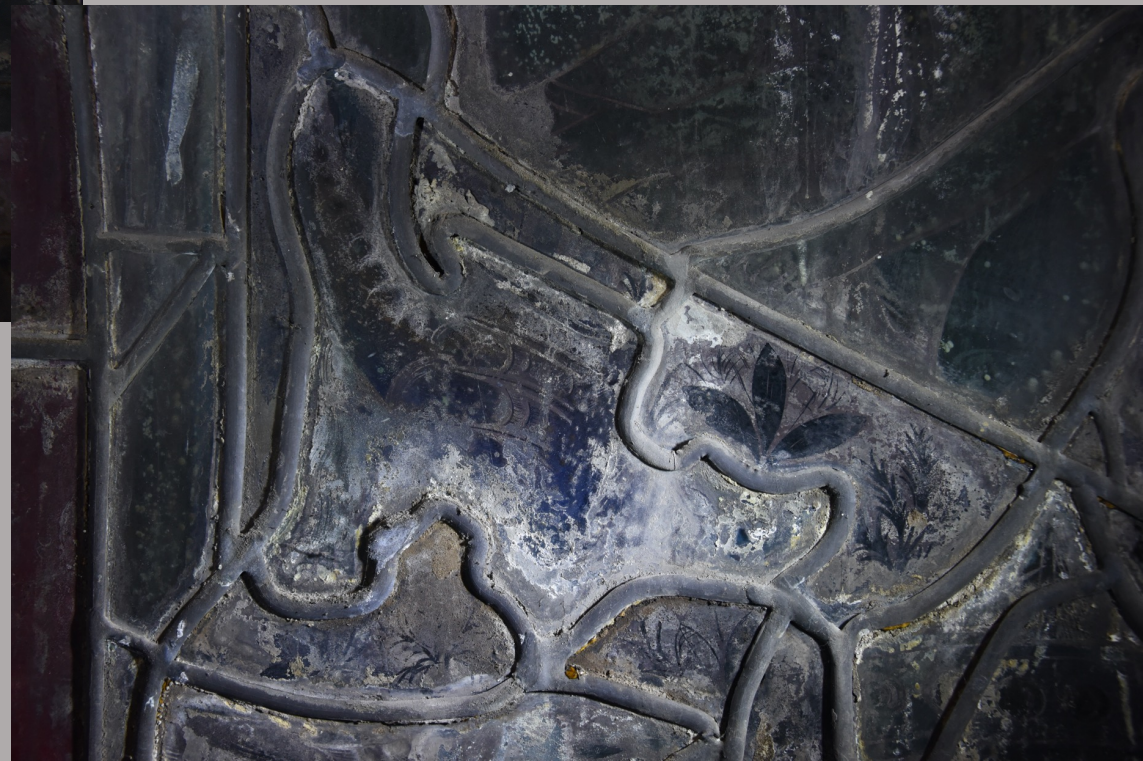
Visual evidence of widespread water ingress and settlement of moisture on the internal window surfaces – leaking and/or condensing moisture

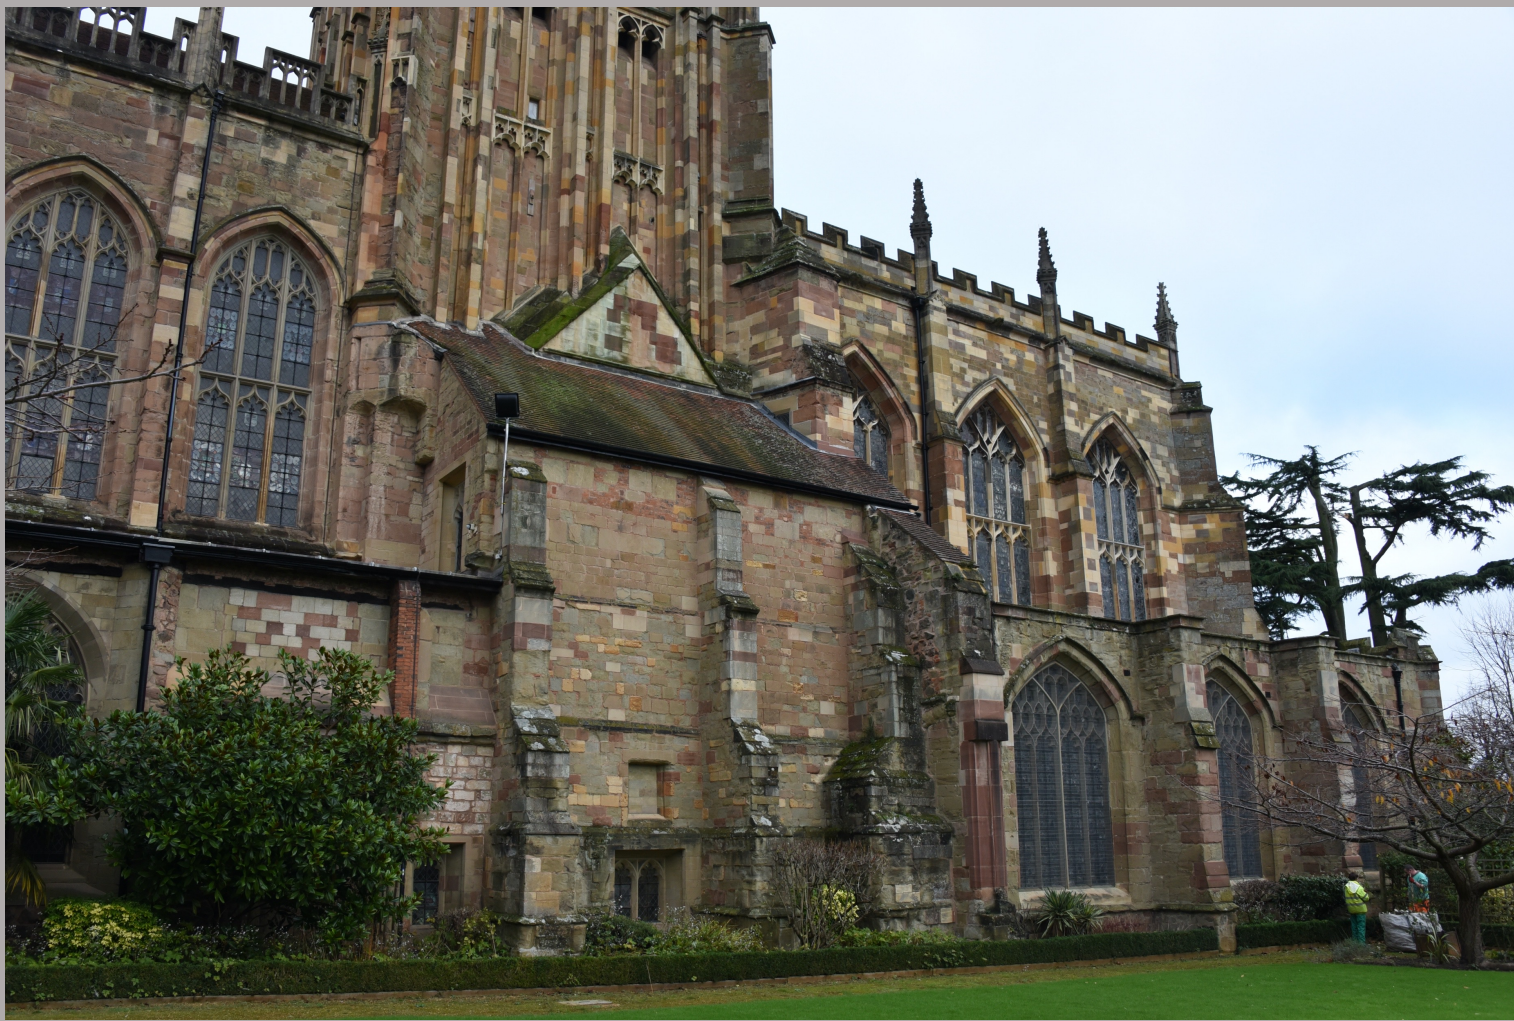
Damp location despite southern prospect

Encroachment of hotel garden and its vegetation

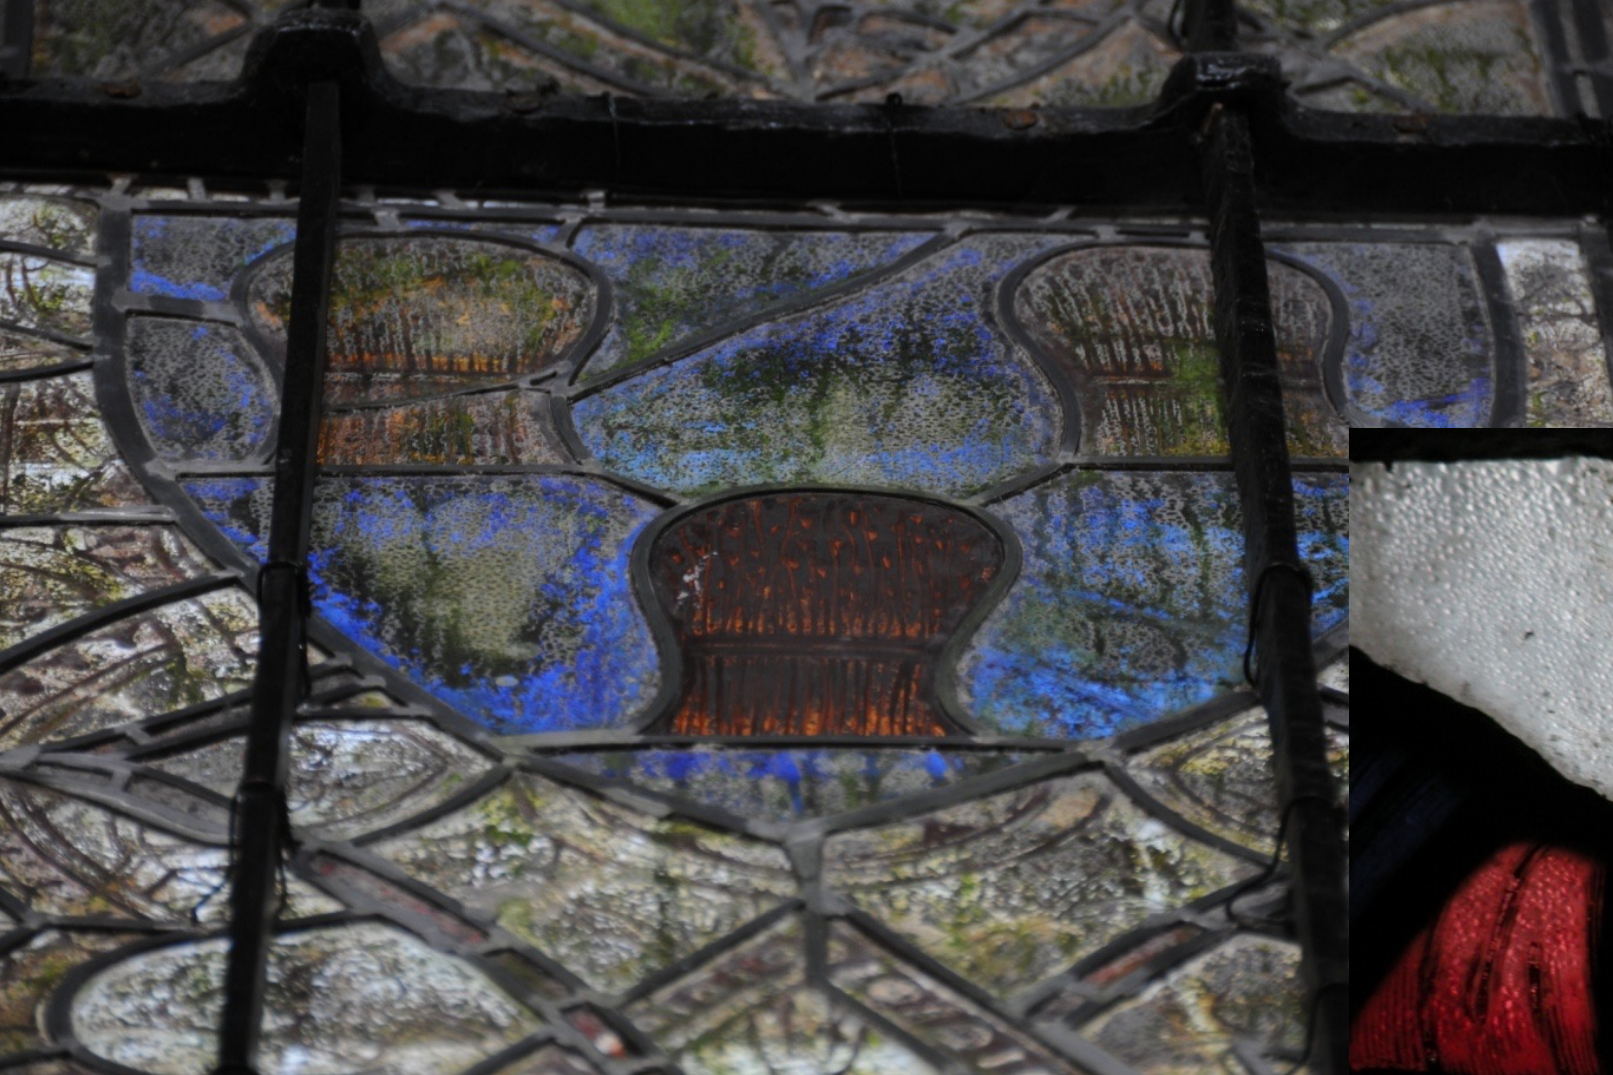
Condensing moisture on internal surfaces

Left: Norbury, C14

Right: Skelton upon Ure, Yorks, 1870s

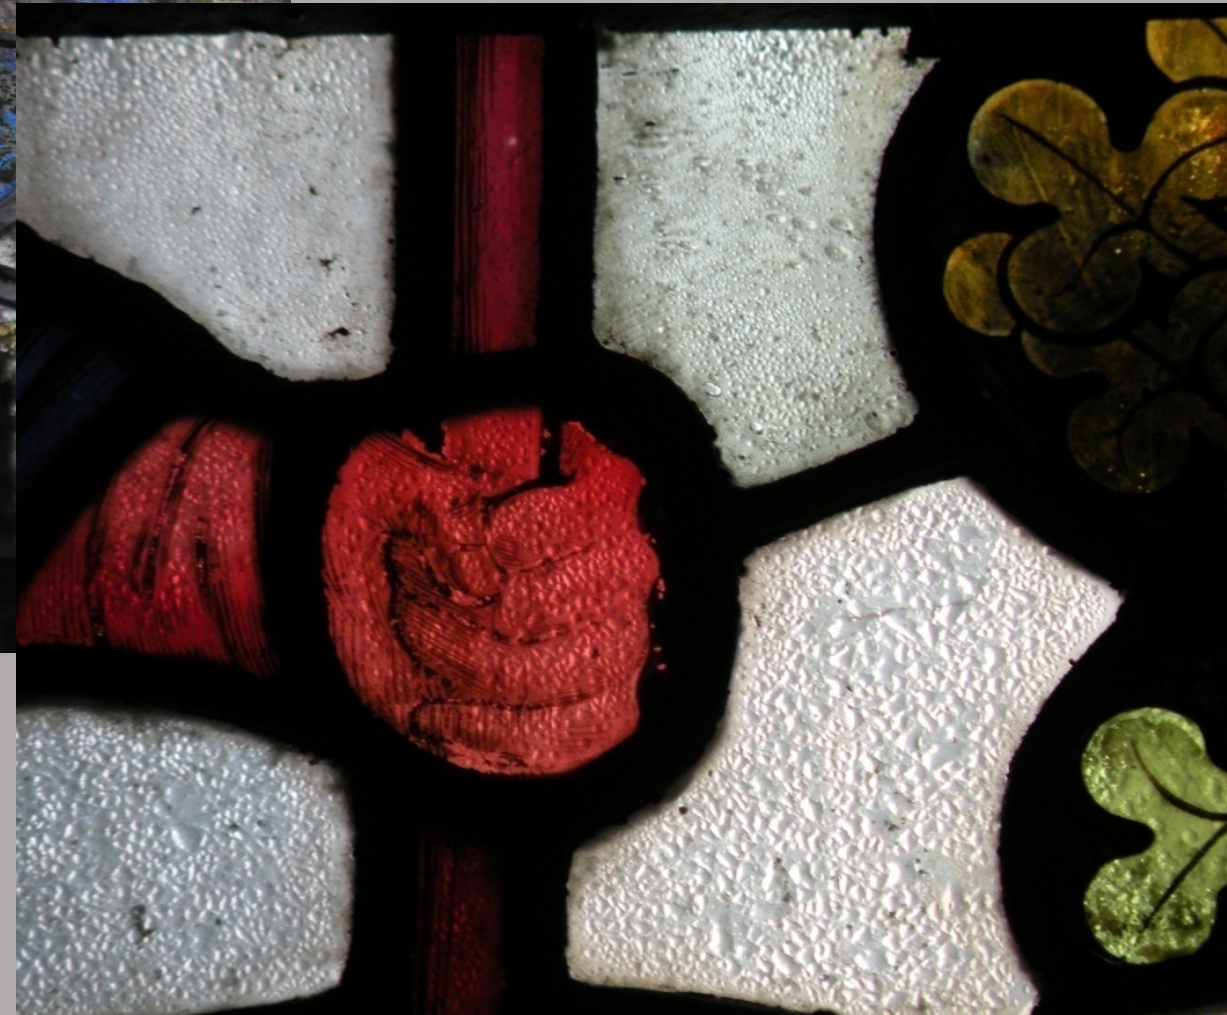
Silicate structures:  
Quartz (left), Glass (right)

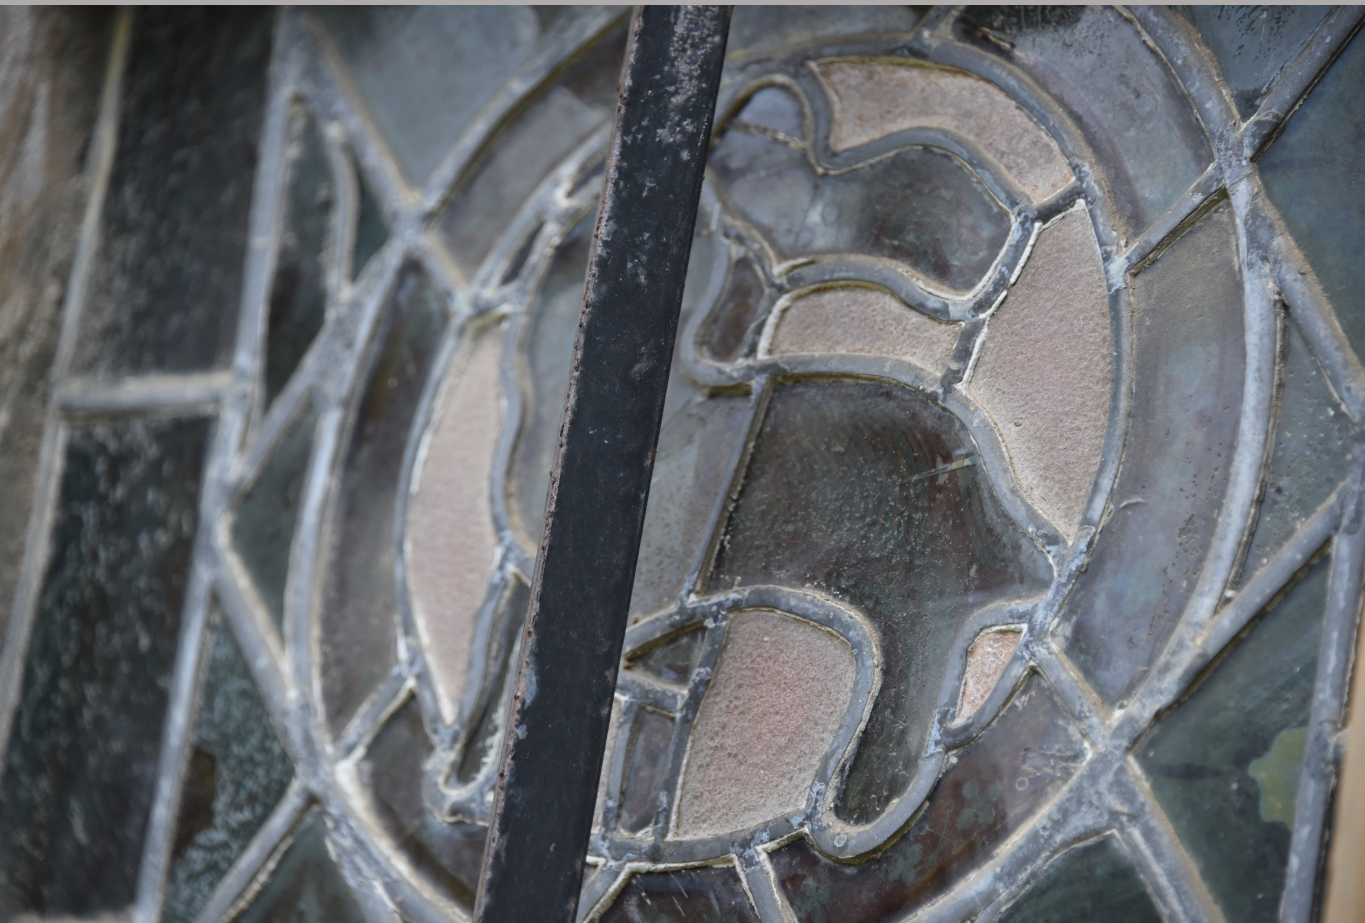
Glass Composition affects response to moisture attack:

Merton College, Old Library: LW ell exterior, showing heavy corrosion of early C14 red and blue glasses

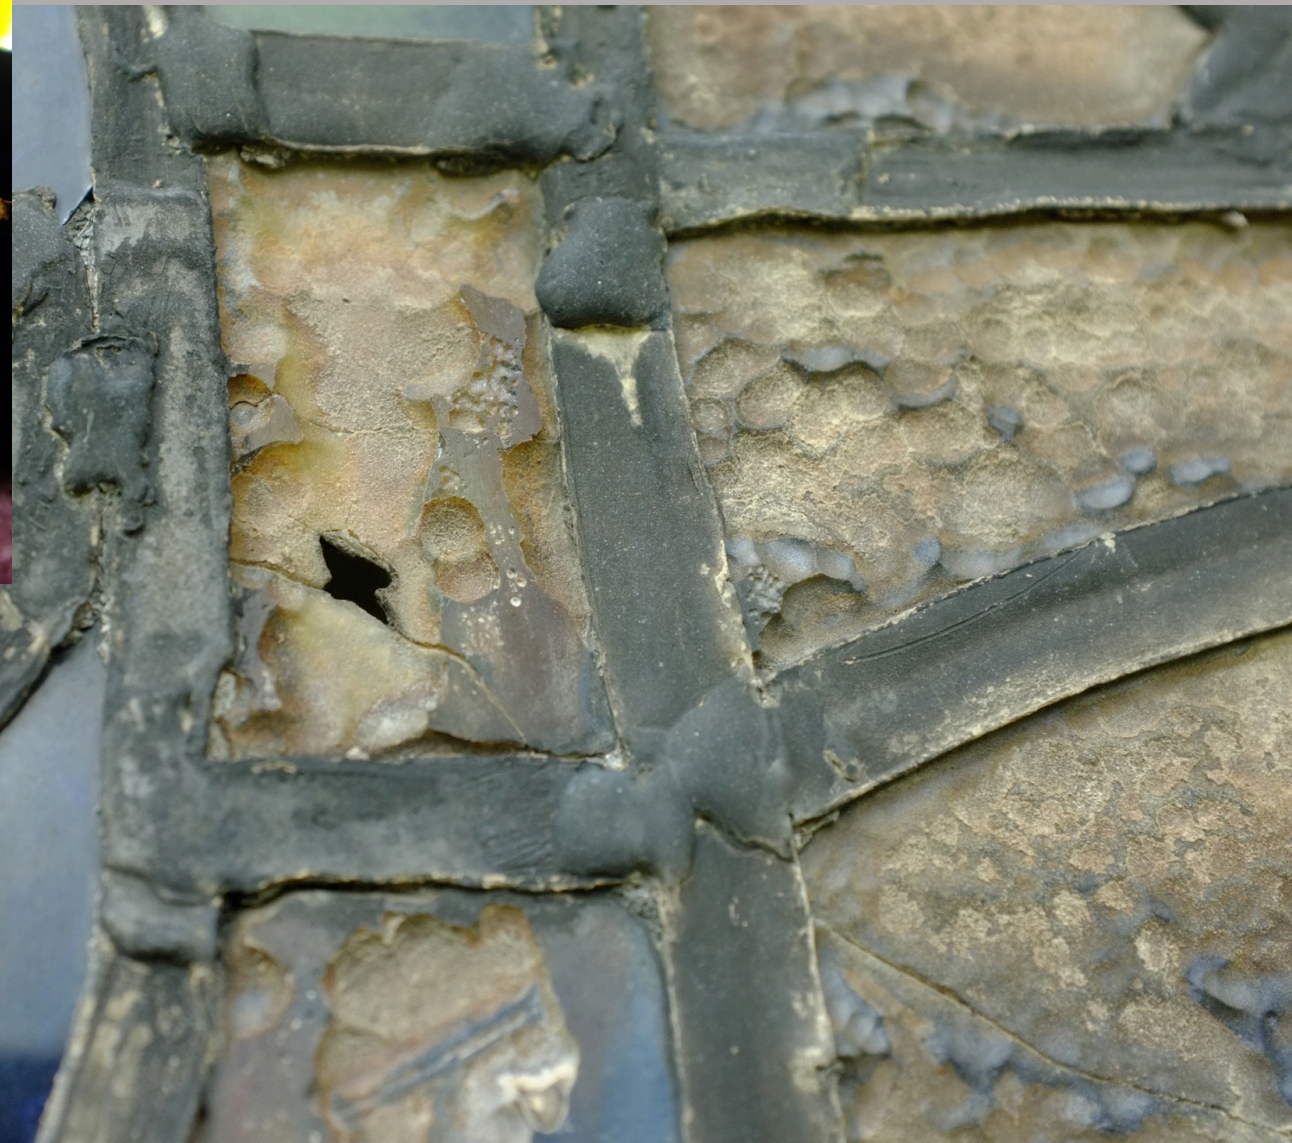
Coalescing pits eventually  
create holes (York Minster,  
north nave aisle)

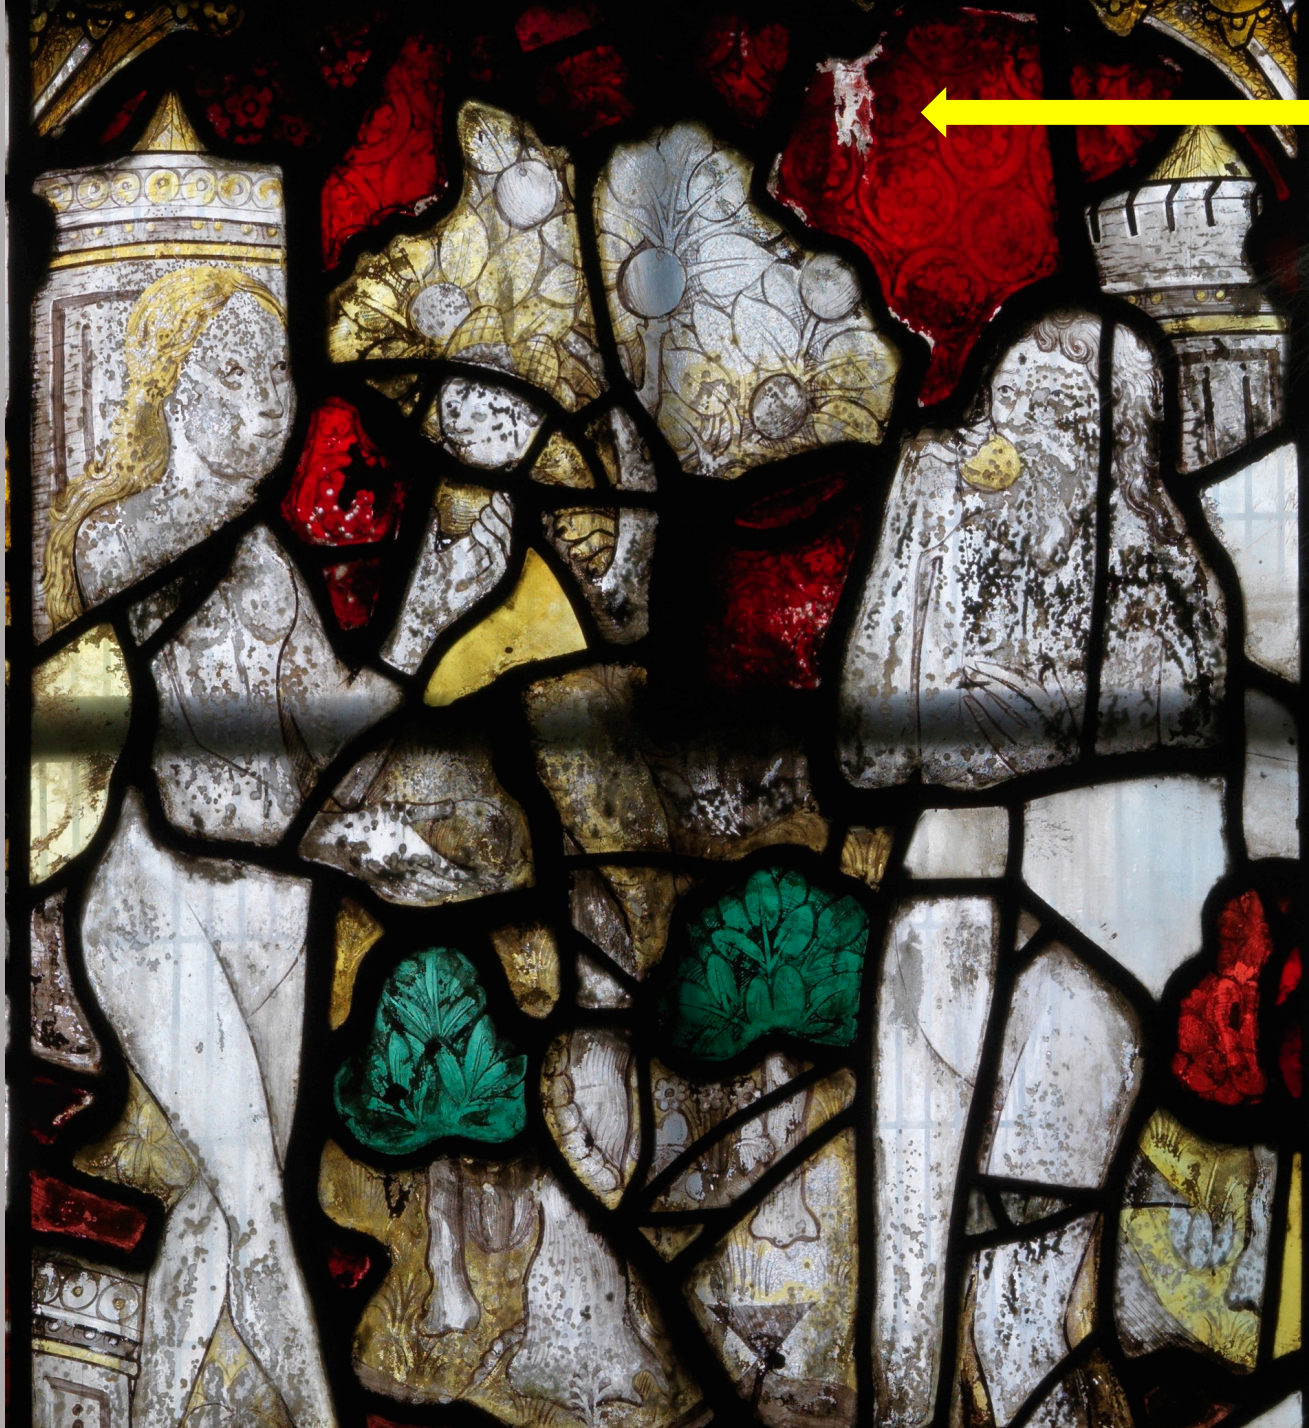
Corrosion of flashed ruby glass changes the colour palette

Paint loss reduces legibility and undermines historic, artistic and aesthetic value of the window
