# Great Malvern's Creation Window The Conservation and Protection of a Medieval Treasure

Professor Sarah Brown FSA FRHistS

Director, The York Glaziers Trust

# Findings of the 2015 survey

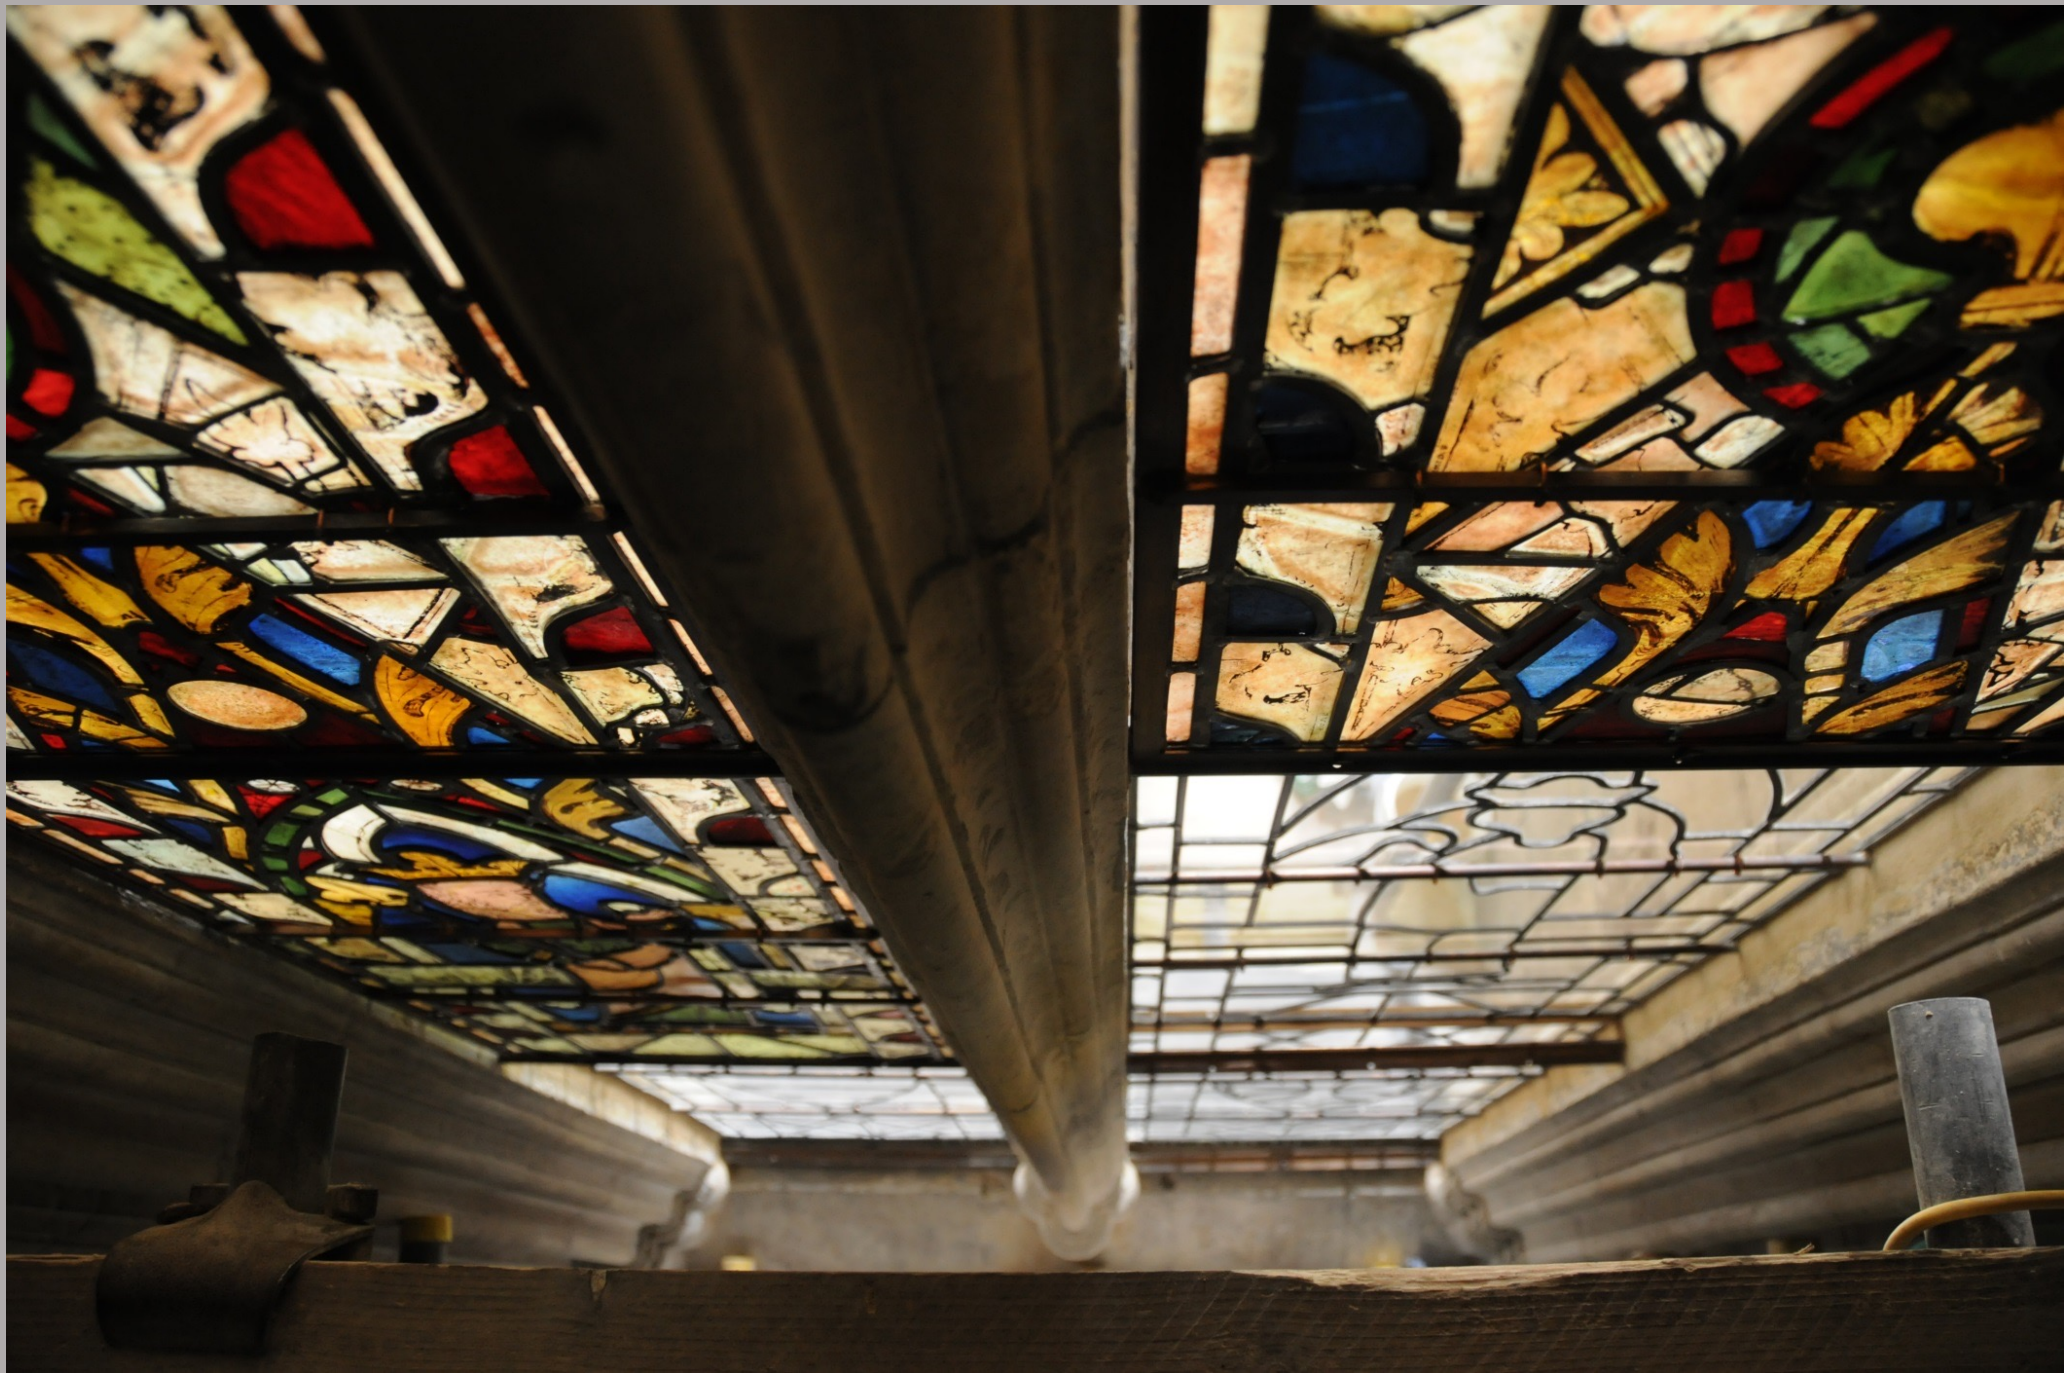
# GREAT MALVERN PRIORY THE CREATION WINDOW sIII

## PROPOSED ENVIRONMENTAL PROTECTIVE GLAZING POSITION

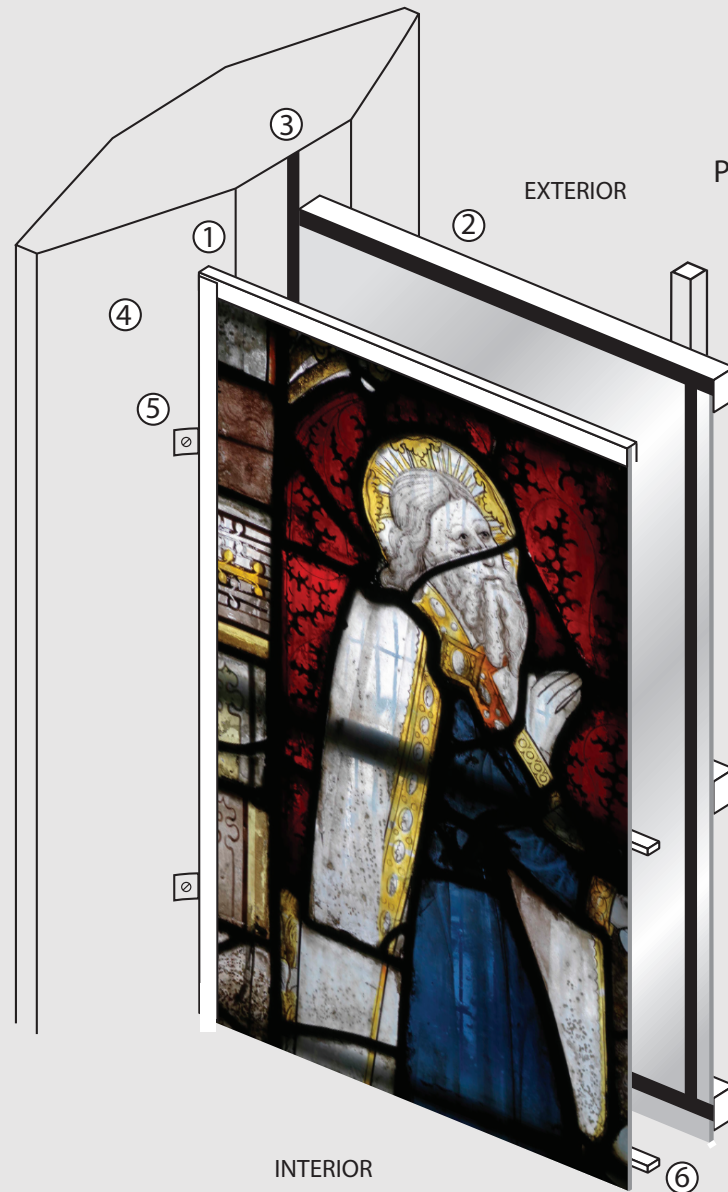
- ① Original stained glass set into a bronze frame with integral bronze support bars placed behind the stained glass
- ② Protective glazing panel made with lead and clear glass divided in line with pattern of support bars
- ③ Original glazing groove in a stone mullion. Protective glass is set here and weather-proofed with traditional lime mortar
- ④ Inner face of the mullion. Framed stained glass panels positioned here
- ⑤ Screw-fixing bracket to frame, providing a secure hold to the stone work
- ⑥ Bronze support bar (integral to frame)

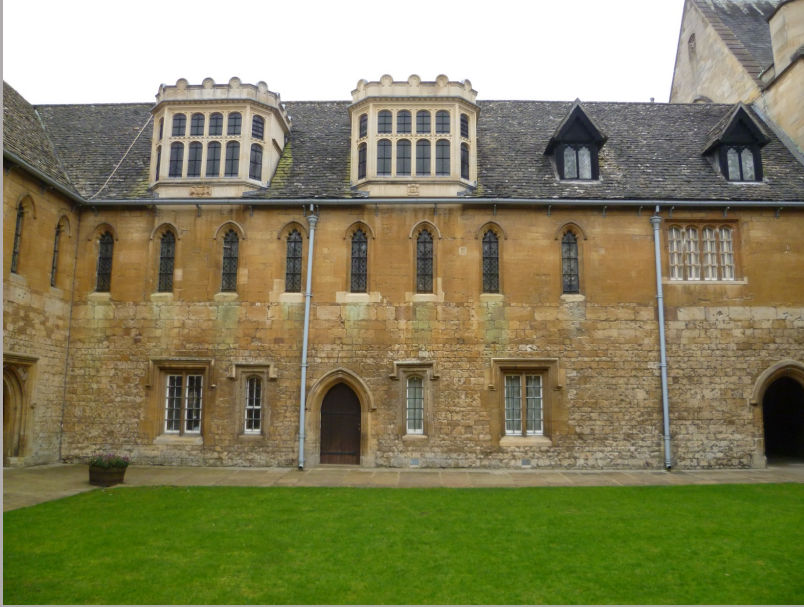
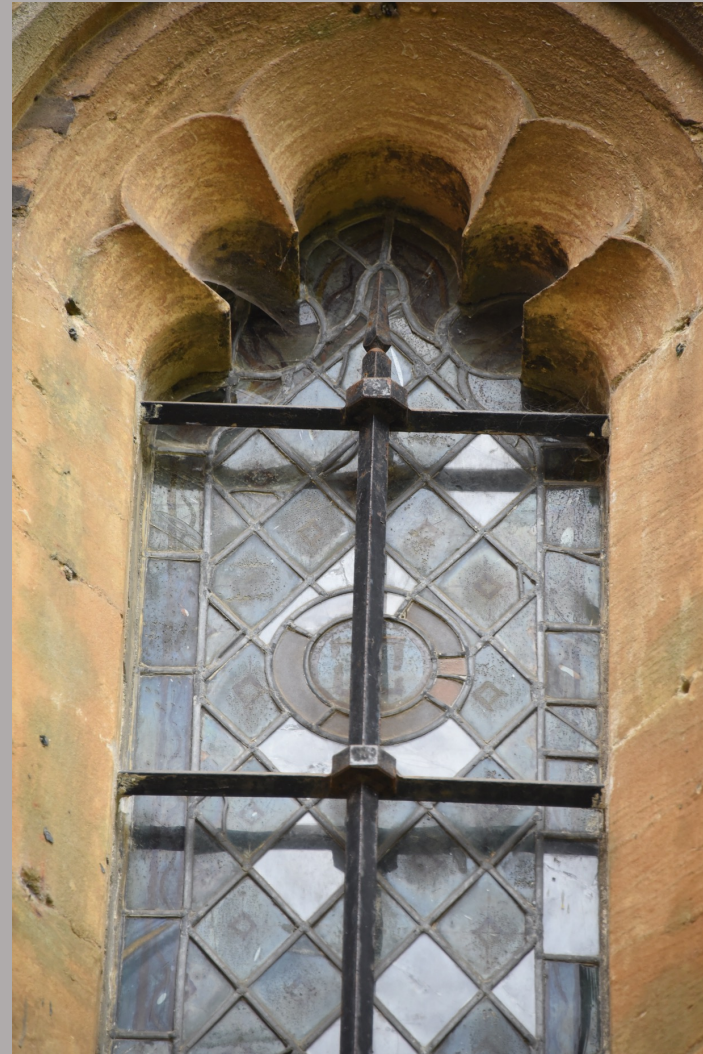
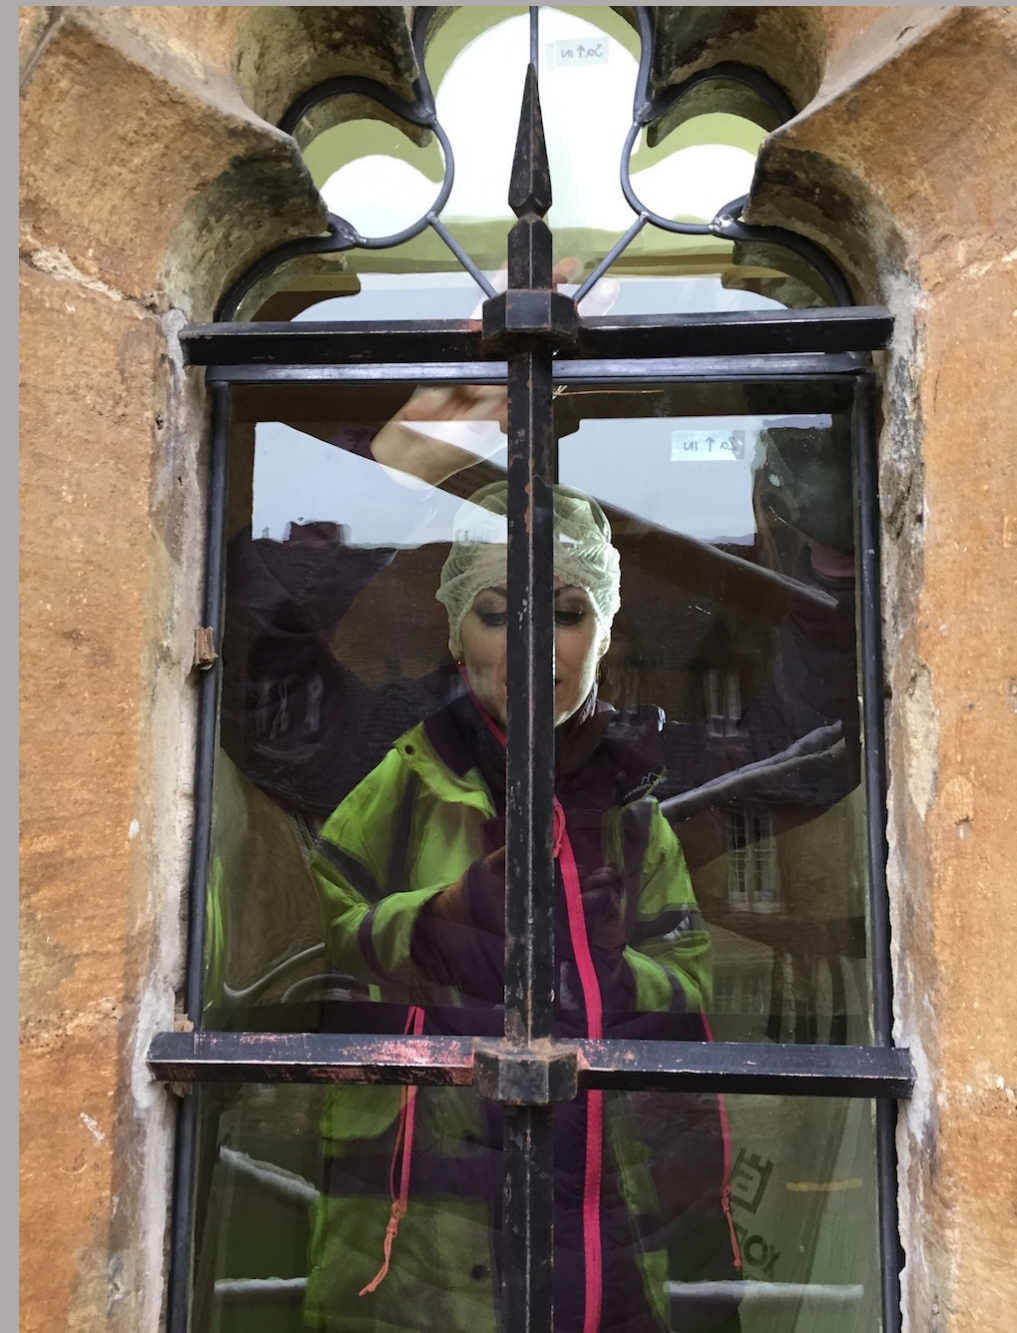
Merton College Old Library, exterior  
ferramenta and introduction of protective  
glazing

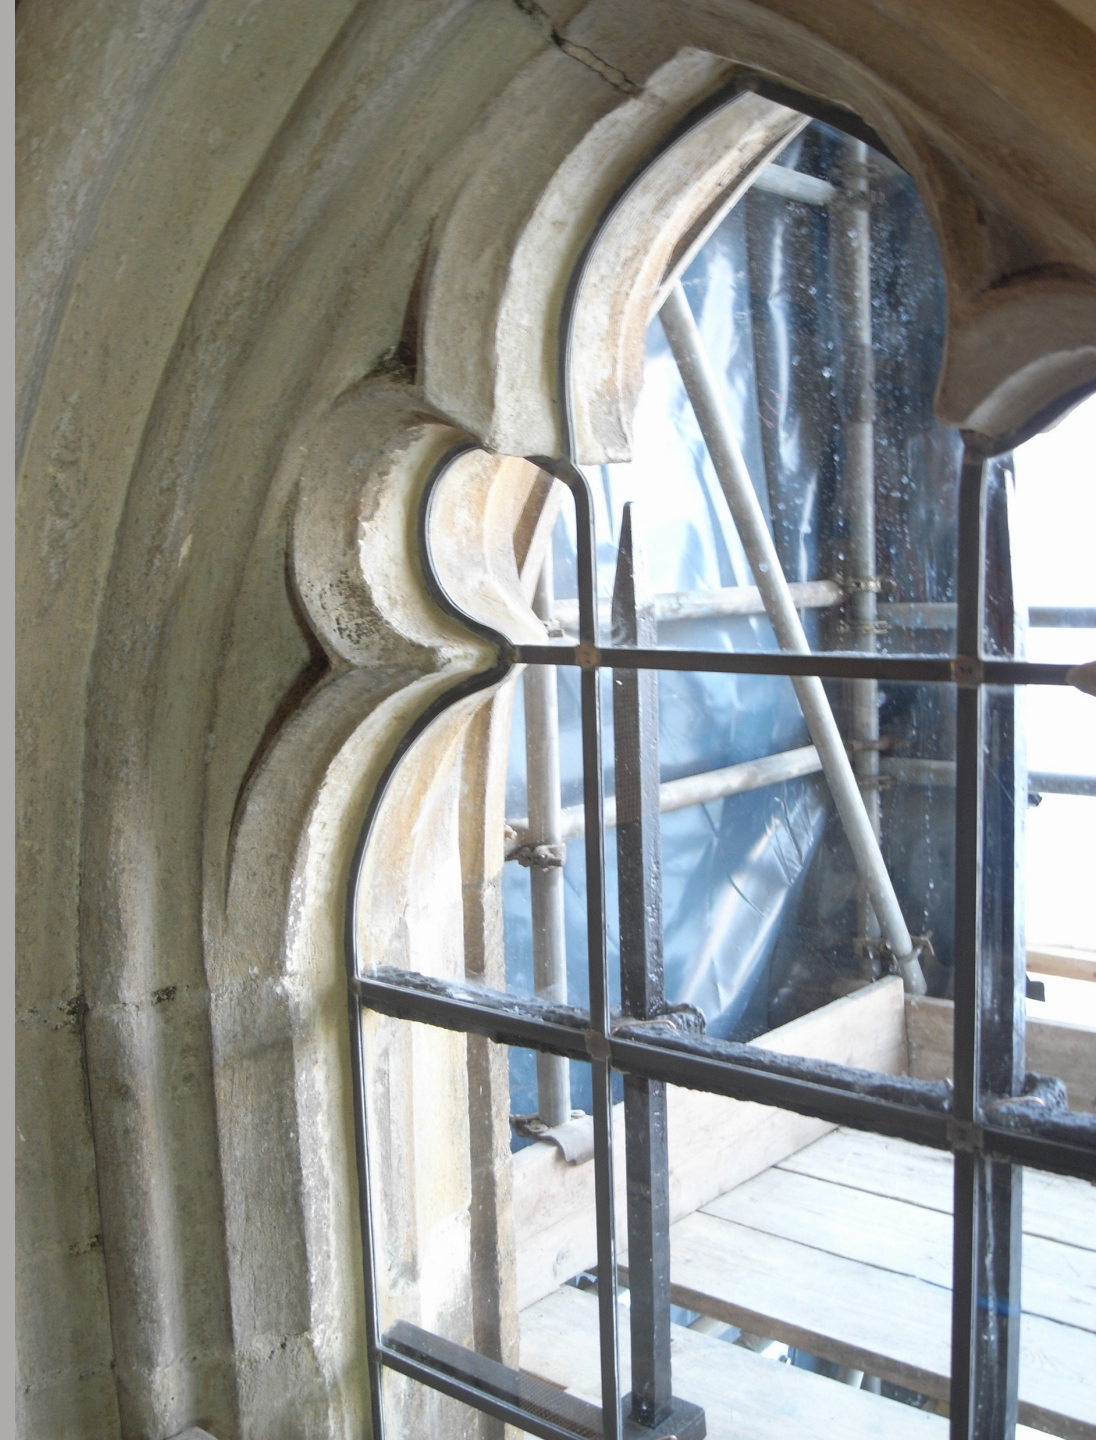
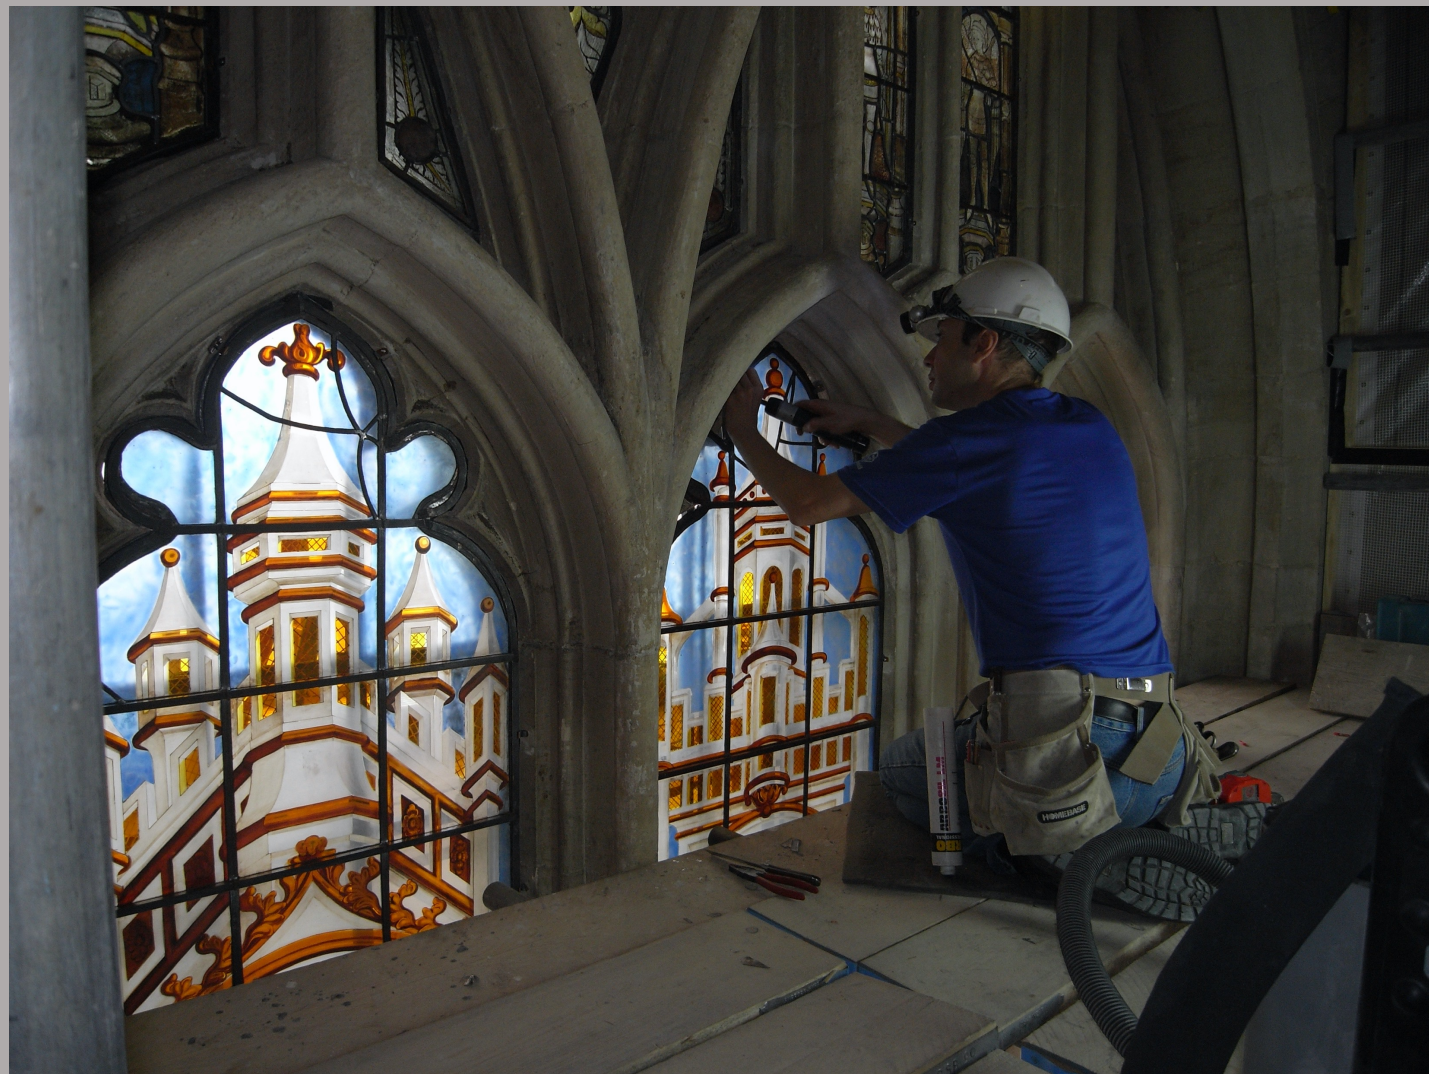
New College Chapel nV: outer glazing matched to patterns of the ferramenta – simple and cheap to make

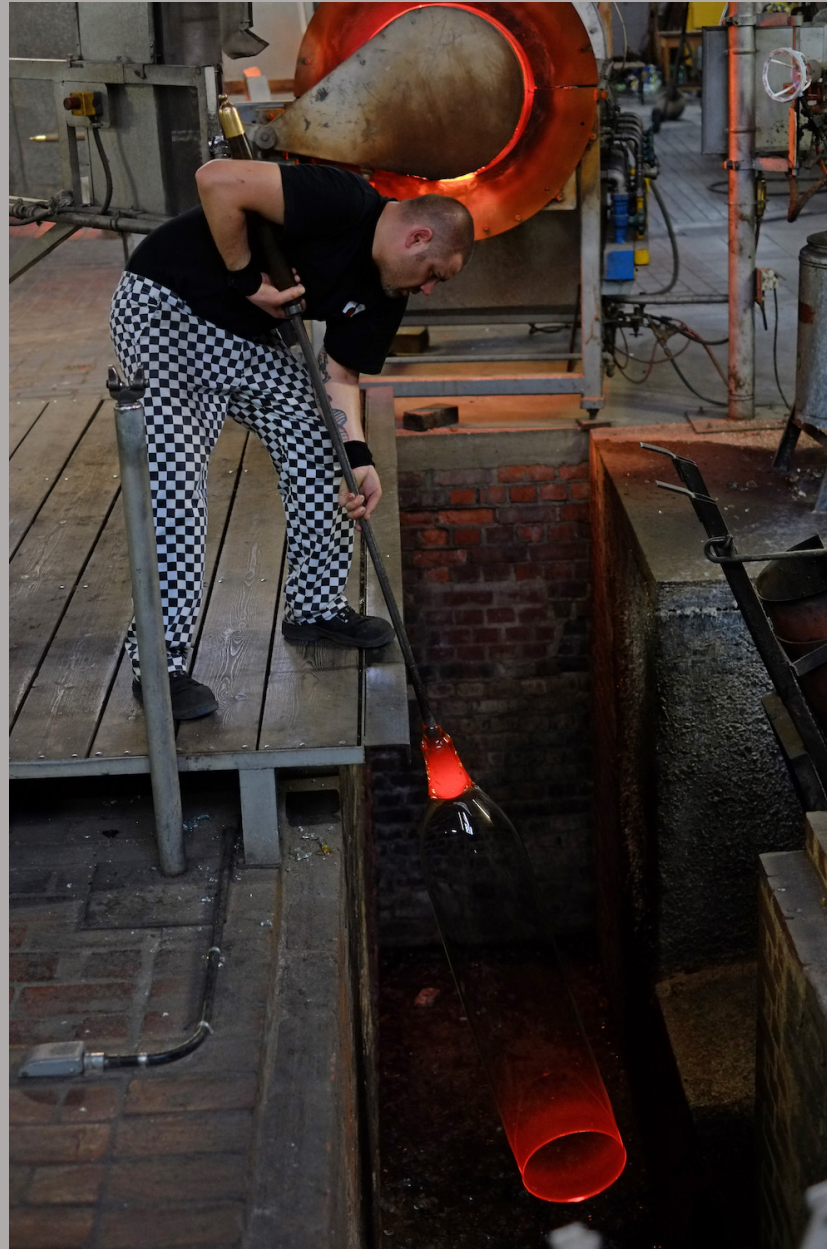
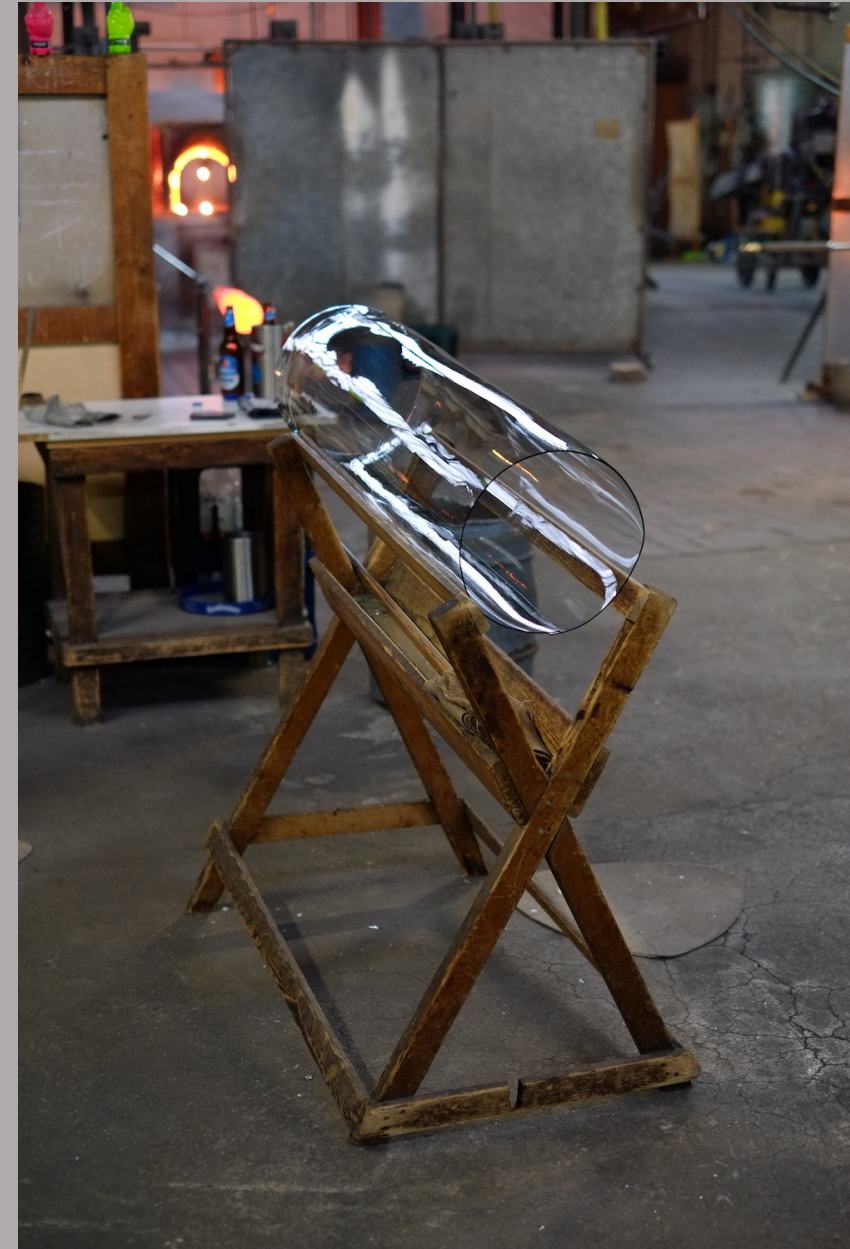
Production of Restauro glass at Lamberts Glasshouse, Waldsassen, Bavaria

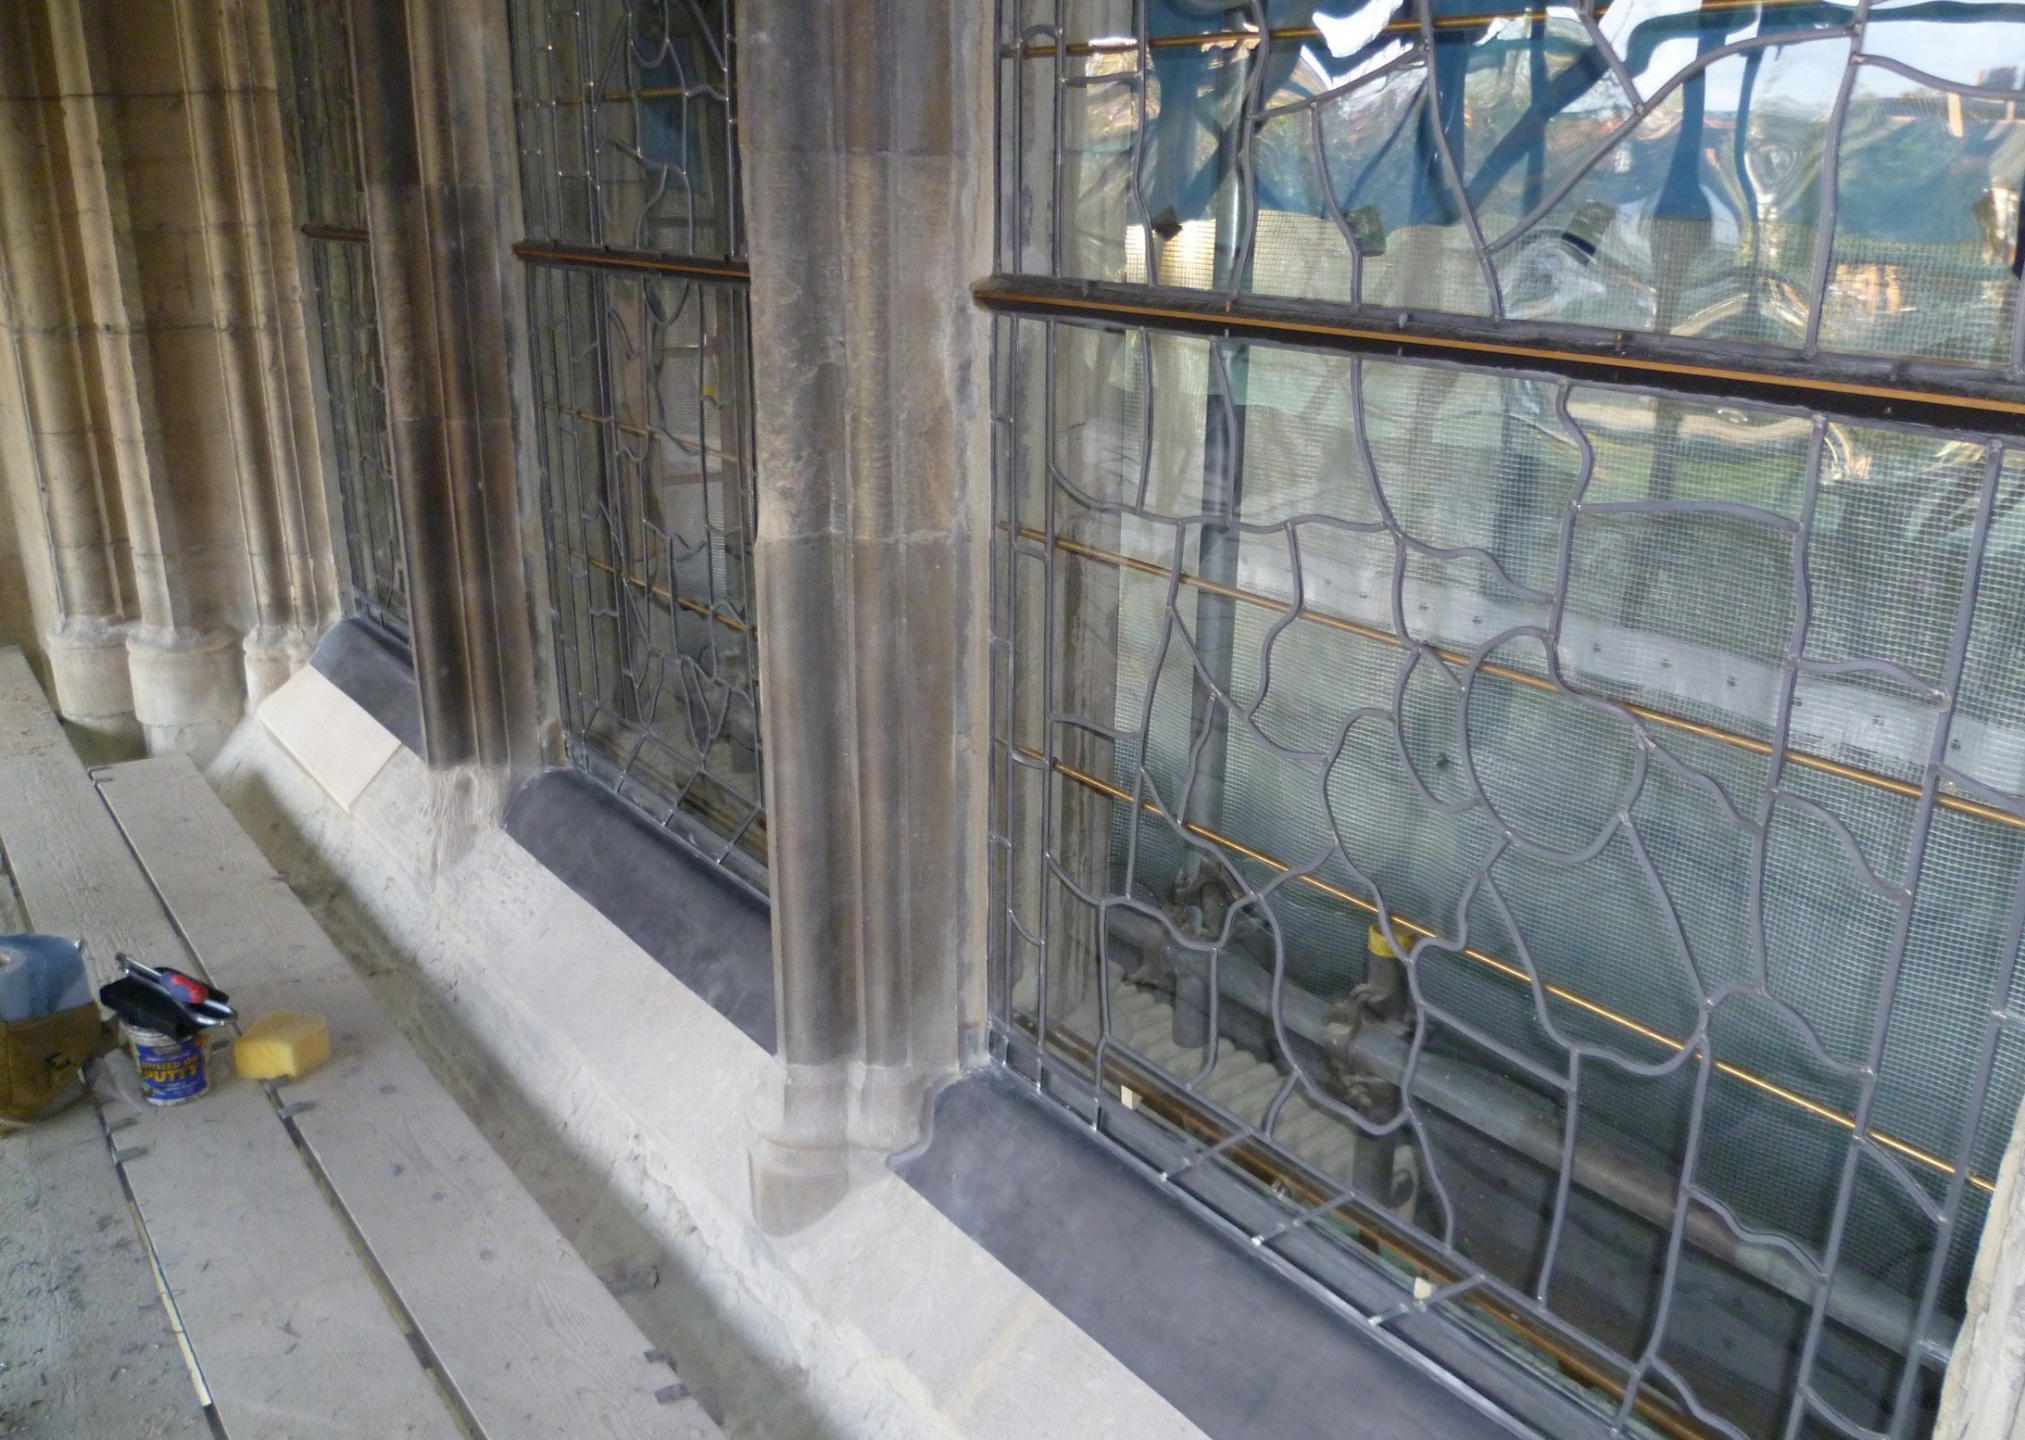
A cheaper option:  
kiln distorted  
horticultural glass

Recently installed  
external glazing for  
York Minster window  
nII, 2013, with a  
simplified leaded  
pattern
